Mechanical Impact of High Temperature Stripping Of Induction Motor Stators

Howard W Penrose, Ph.D., CMRP
Vice President, Engineering and Reliability Services
Dreisilker Electric Motors, Inc.

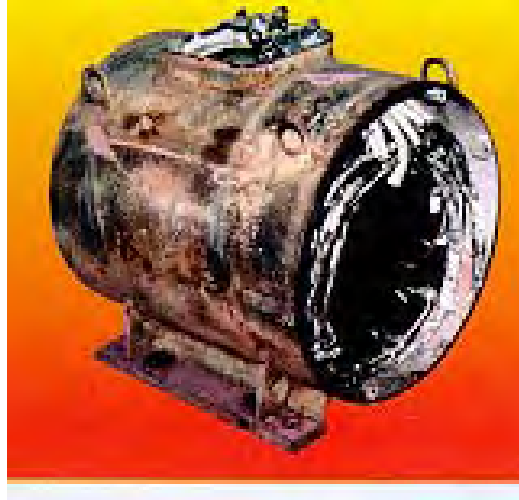
Figure 2: Burned Out Rolled Steel Stator

As there was a significant increase in soft foot and stator deformation in the aluminum stators at 650F, the 800F test was performed on cast and rolled steel stators only. There were significant changes in soft foot, rabbet fit concentricity and core steel position. Visually, the stators and some warping and oxidation was found on all stators within two days. There were severe instances of loose laminations in all of the stators.

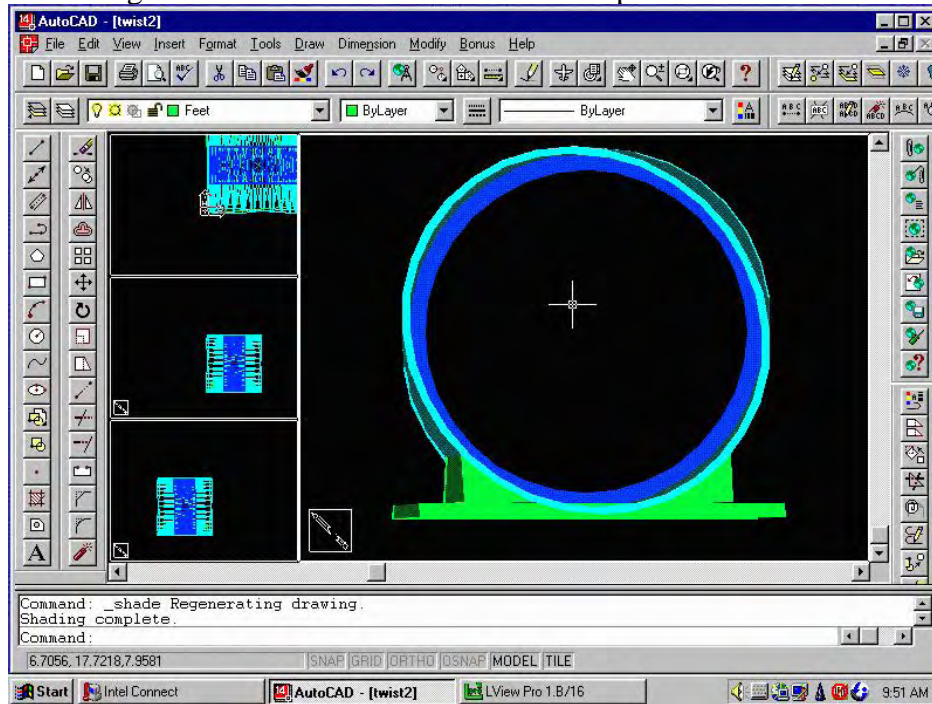
Figure 4: Model Modified in AutoCAD per Measurements

Modeling the results created an understanding of what was truly happening to a motor in which even minor distortion was occurring. Those results were fairly dramatic and go a long way to help determine why some repairs do not seem to last as long as others.
