Dreisilker Electric Motors, Inc. - Job # 388053

Motor Failure

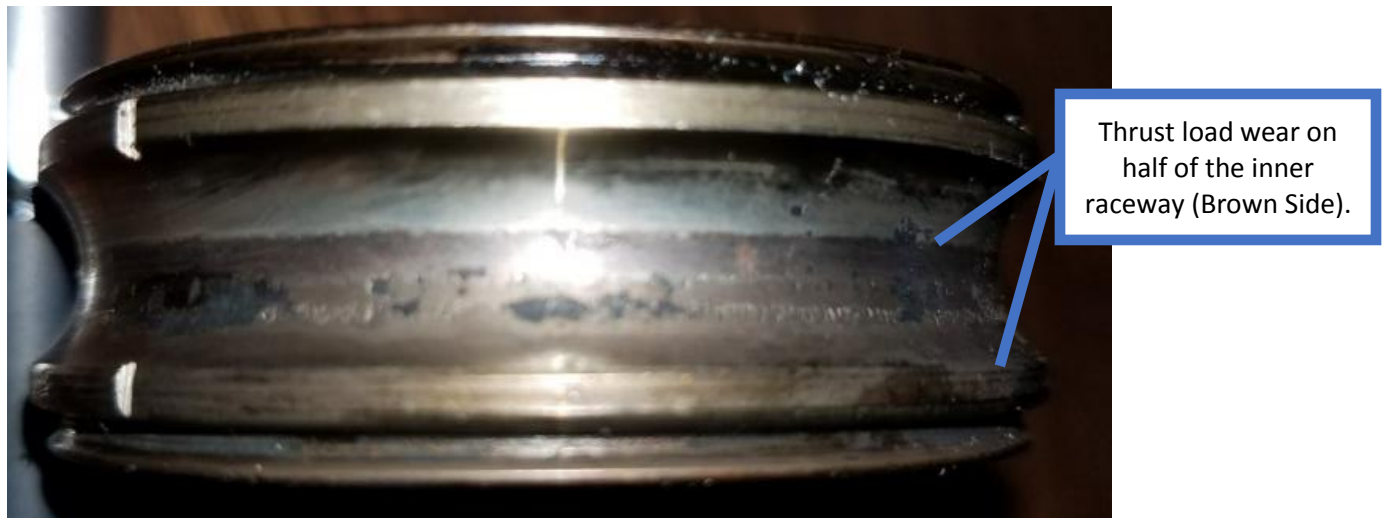
Cause of Failure: The opposite drive end bearing locked up. The motor was found to have a bent shaft and a bad bearing housing. The bearing was cut in half and it was found to have a condition indicating excessive thrust load (Figure 1). Excessive thrust wear is shown by an even pattern directly on one side of the raceway. It is caused by an axial overload. This could indicate improper mounting of the motor or a problem with the machine. It is possible the shaft was bent during installation or the machine has a problem.

Figure 1: Excessive Thrust Load on the Opposite Drive End Bearing

Possible Solution: When mounting the motor on the machine, ensure that the motor shaft and machine mating part is clean and has no burrs. Use an anti-seize to mate the motor shaft and the machine mating part together. When pushing the motor into the mating part of the machine, ensure that the motor is not cocked at an angle to avoid bending the shaft or damaging any other components. Also, ensure that the machine is not overloading the motor or pulling on the motor shaft axially by adjusting the mating couplings with correct spacing.

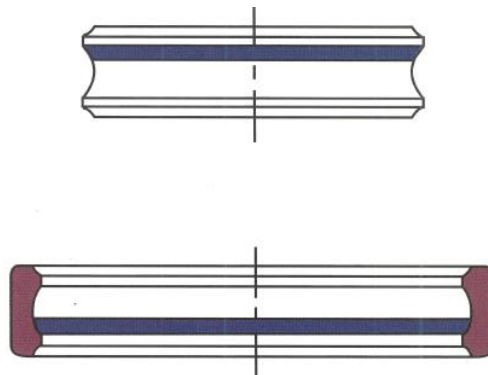
Figure 2: Example of Excessive Thrust Load Wear
