Cause of Failure for 200 HP Weg Motor

Dreisilker Electric Motors, Inc.

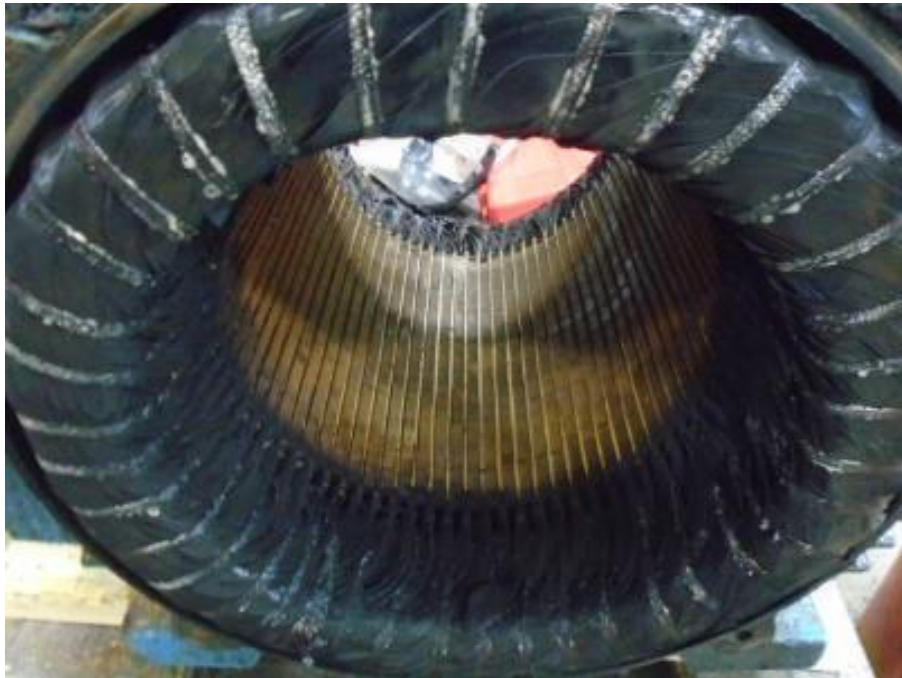
**Overheated Insulation and DE bearing Grease Contamination on DE Winding Head**

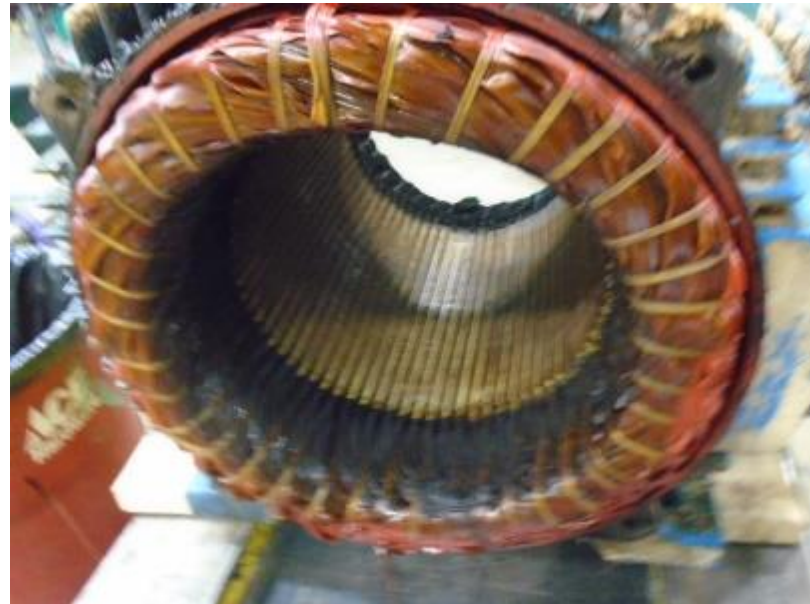
**ODE Winding Head with DE bearing Grease Contamination**

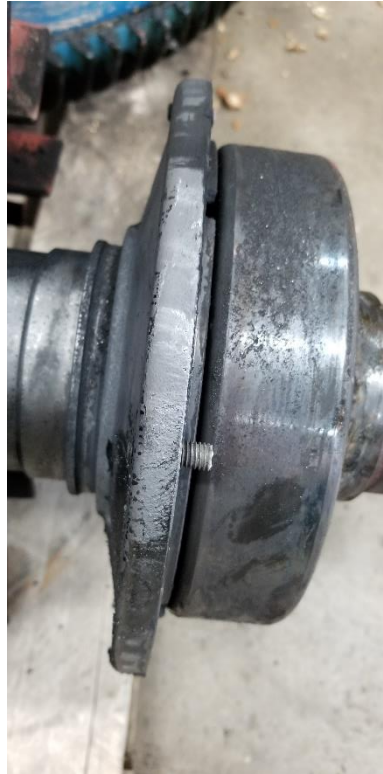
**Broken Bolts on DE Bearing Cap**

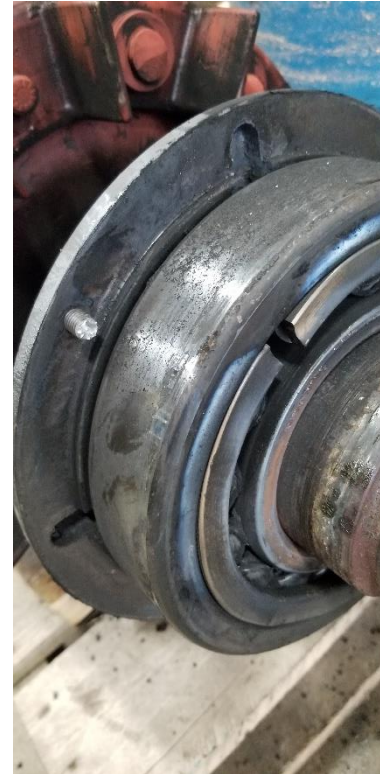
**DE Bearing Failure**

- The DE bearing journal was metal sprayed and machined out of tolerance oversized
- The DE bearing began fretting causing overheating and breakdown of lubrication (no evidence of contamination, bearing race ways failed catastrophically)

- Ensure motor repair shop is machining bearing dimensions to proper tolerances and not using metal spray
- Metal spraying/metalizing leaves a porous surface and should NOT be used to repair rotating components like bearing mating surfaces. Vibration will occur when the rolling elements pass over the pours left from the metal spraying process
- Check lubrication routes on this motor to determine if lack grease accelerated the motor failure (although evidence of burnt grease was in the windings)

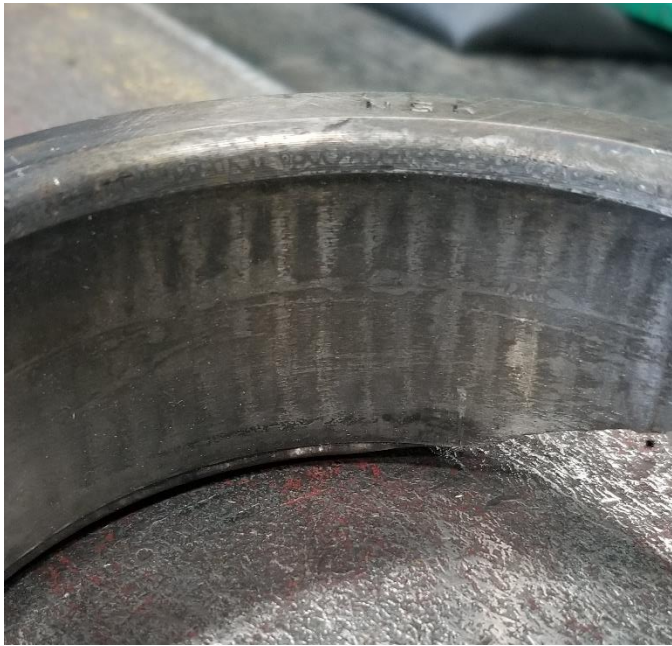
**DE Bearing Inner Race Fretting from Ineffective Oversized Interference Fit**

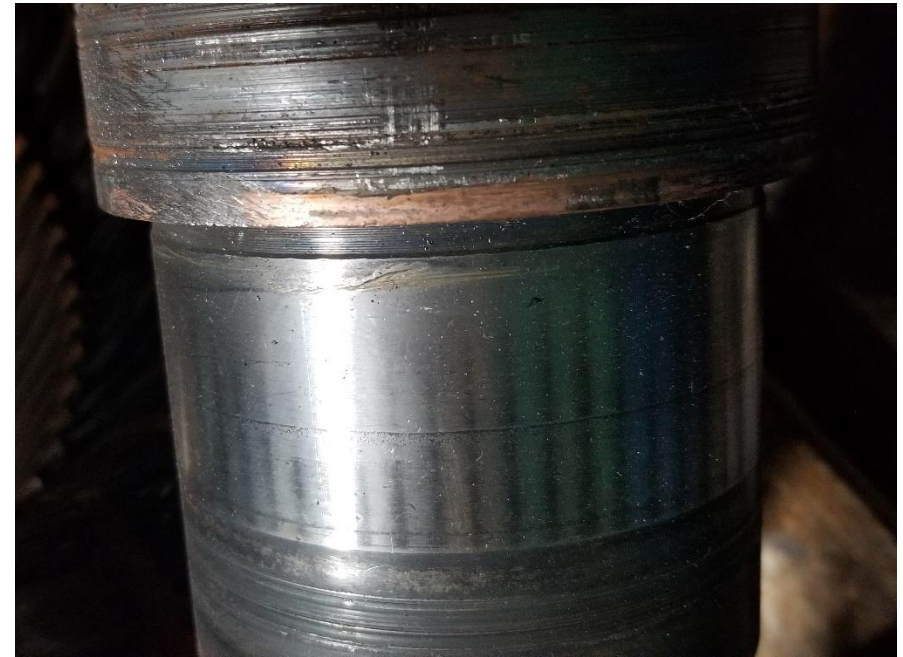
**DE Shaft Journal Fretting from Ineffective Oversized Interference Fit**

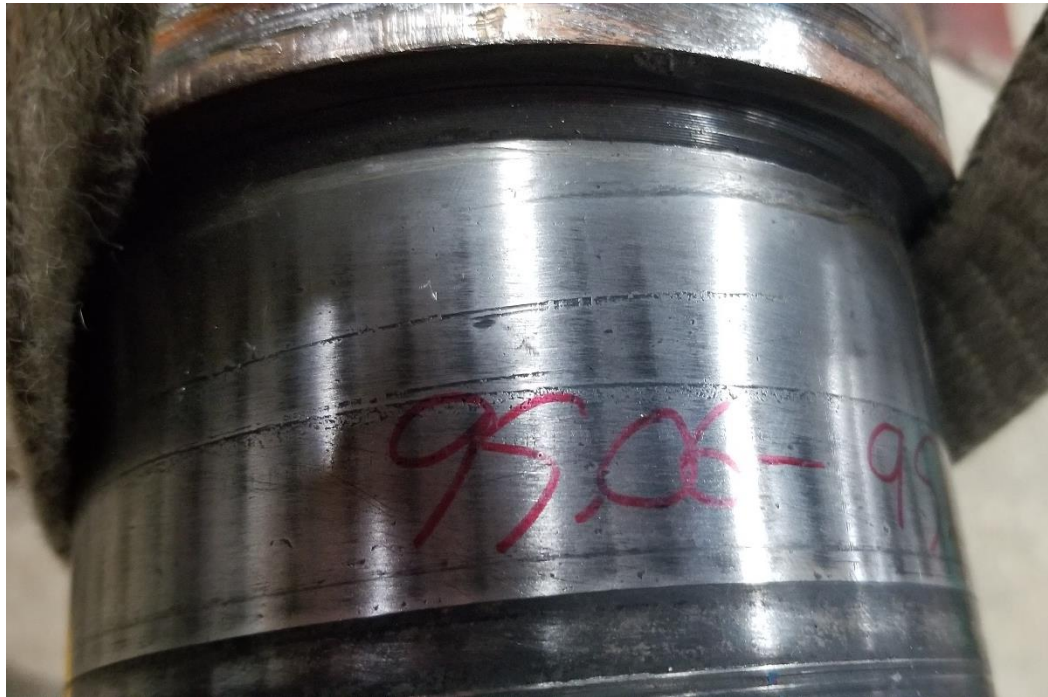
- Motor was repaired by another repair shop
- Evidence of Burnout Stripping
- Winding test okay but overheated on DE winding head
- DE bearing failed
- Balancing weight from rotor found inside motor
- Repair sleeve found on DE shoulder of journal
- DE Journal was metal sprayed and machined out of tolerance and egg shaped (max tolerance = 95.028, journal at 95.061 to 95.081) and bearing inner race had to be cut off for removal

## Porosity Marks on DE Journal, Evidence of Metal Spray

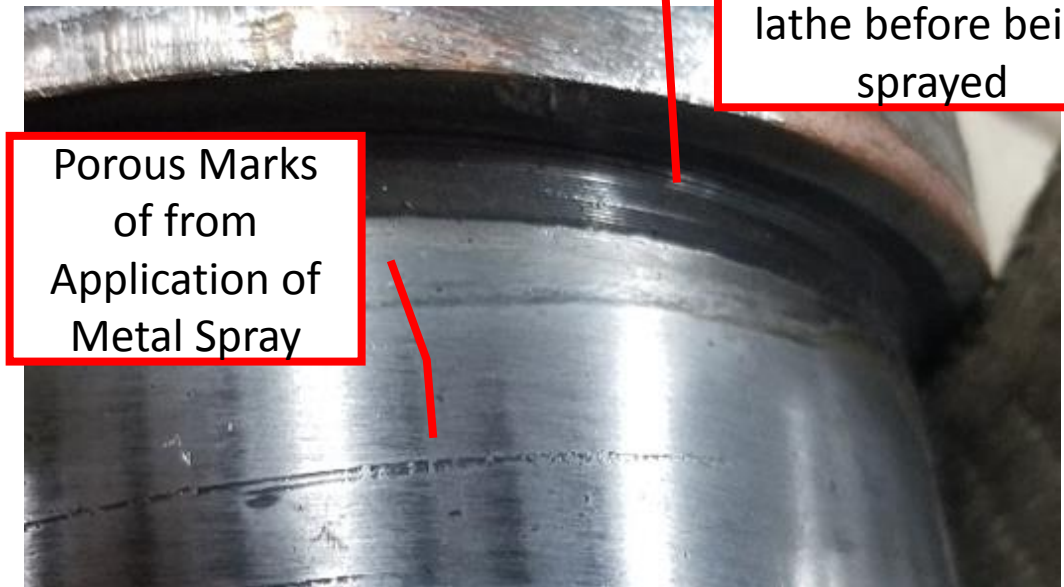
## Close Up of Machined DE Journal Surface

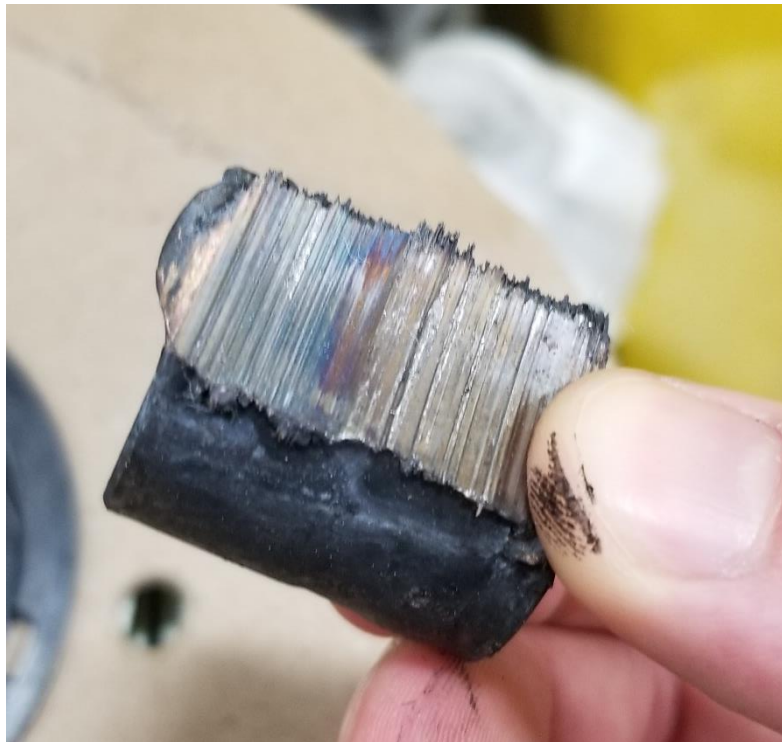
**DE Bearing Roller, Evidence of Ineffective Lubrication or Starvation**

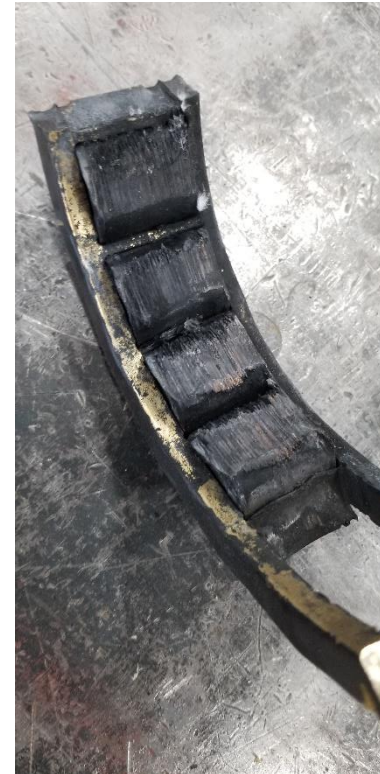
**DE Bearing Rollers and Cage, Evidence of Ineffective Lubrication or Starvation**

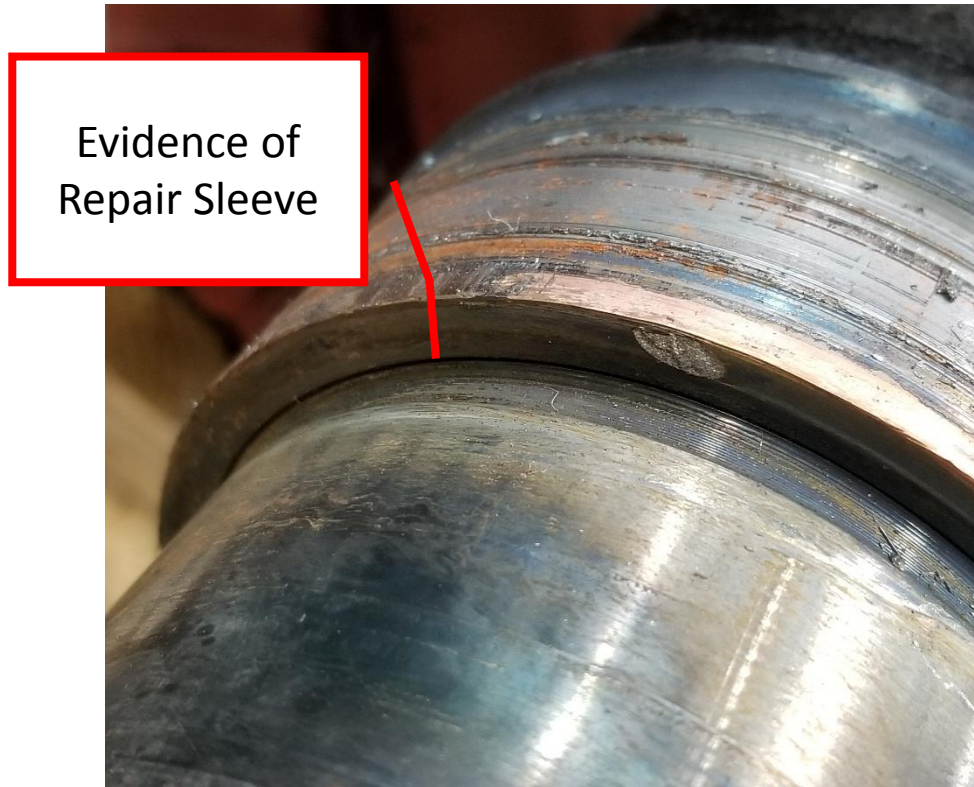
## Repair Sleeve on DE Journal Shoulder

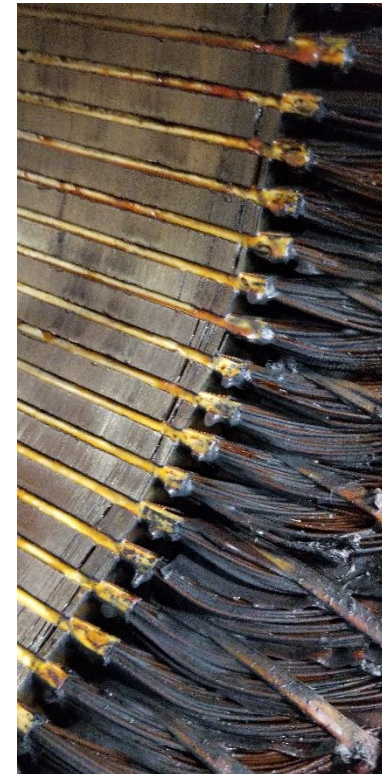
- On this squirrel cage induction motor, the repair shop put two part balancing weight behind the rotor end ring. When the motor overheated it fell off. This was not necessary to use because the rotor has built in balancing posts for adding weight. The weight could have fallen off and destroyed the windings if not for the bearing failure
- The use of a burnout oven cause frame warpage and caused excessive splaying of the laminations

## Excessive Splaying from Burnout Oven Stripping

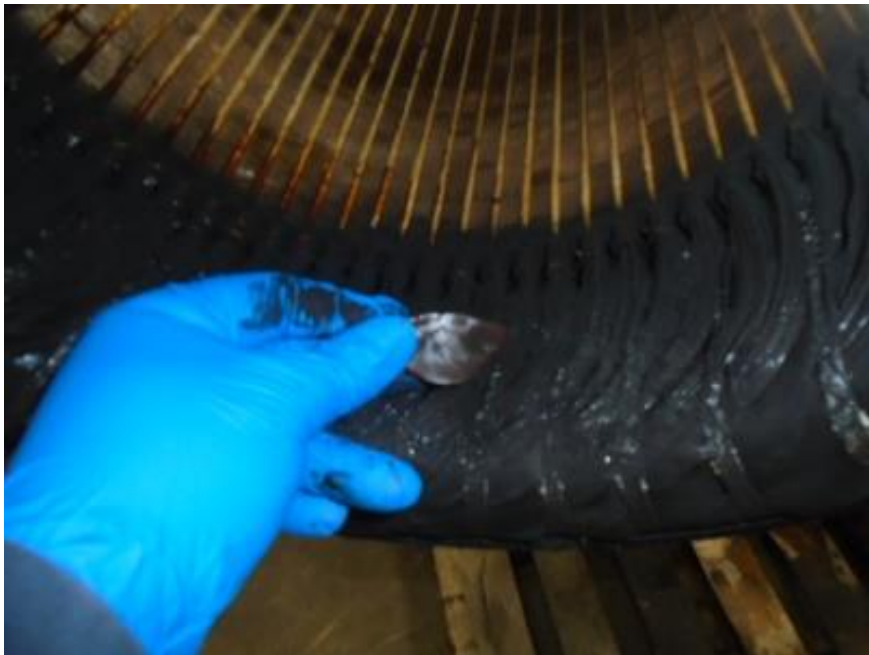
**Two Part Balancing Weight in Windings**

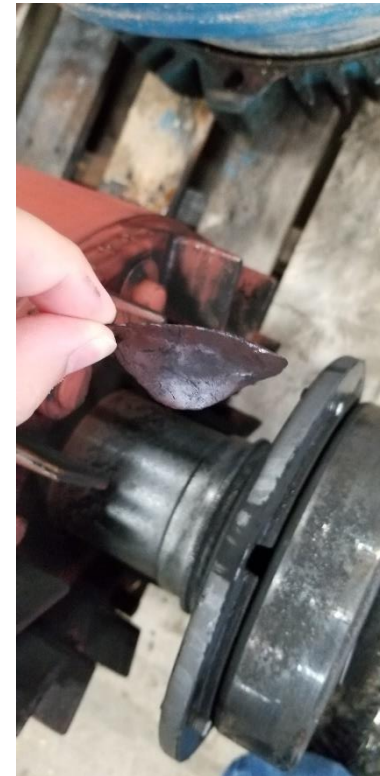
**Two Part Balancing Weight from Inside Rotor**
