Cause of Failure – 200 HP Weg

Dreisilker Electric Motors, Inc.

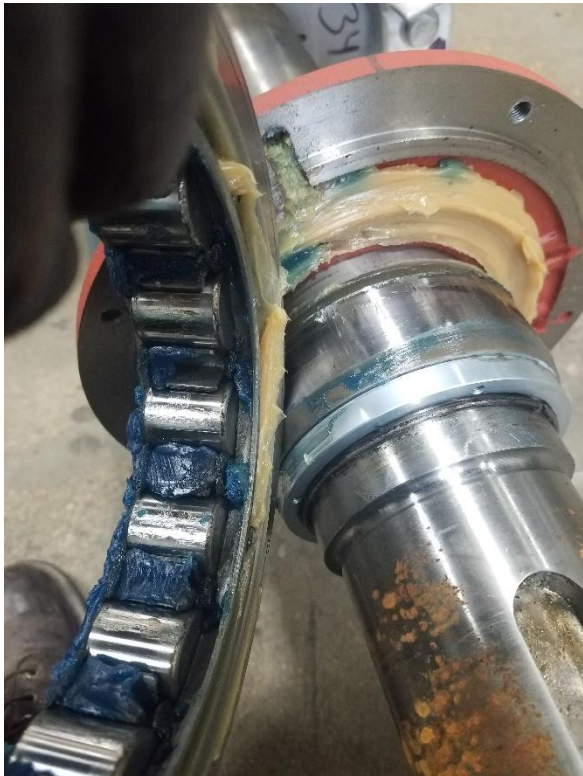
Two different greases in DE bearing and bearing cap

- Make sure lugs are not overtightened
- Verify that the motor connection is correct with the nameplate connection diagram
- We do not know what types of grease were in the DE bearing, verify the greases are correct or compatible to customer standards

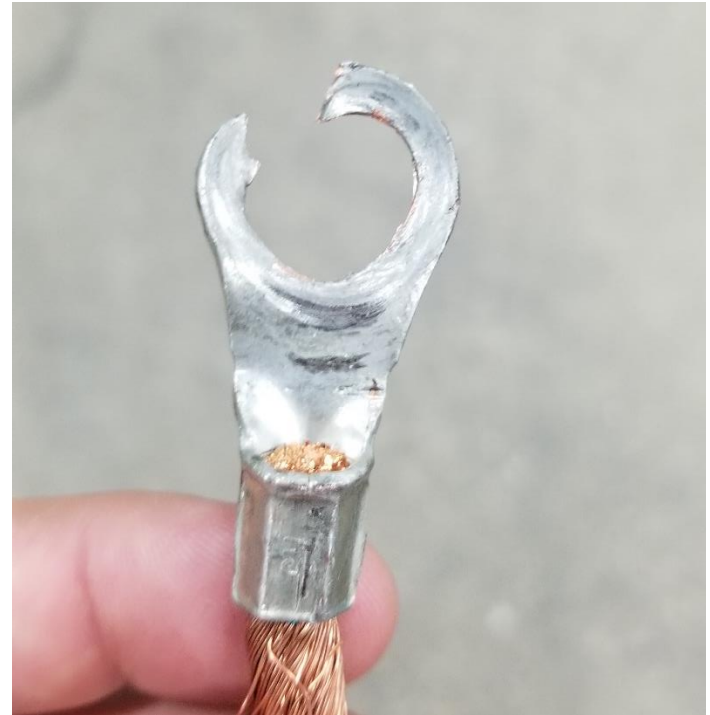
Crushed and split lug

- Shaft runout was 0.004 inches and higher than NEMA's tolerance
- Two terminal posts were swapped, which could have caused an electrical issue if connected wrong
- One lug wire was damaged from overtightening

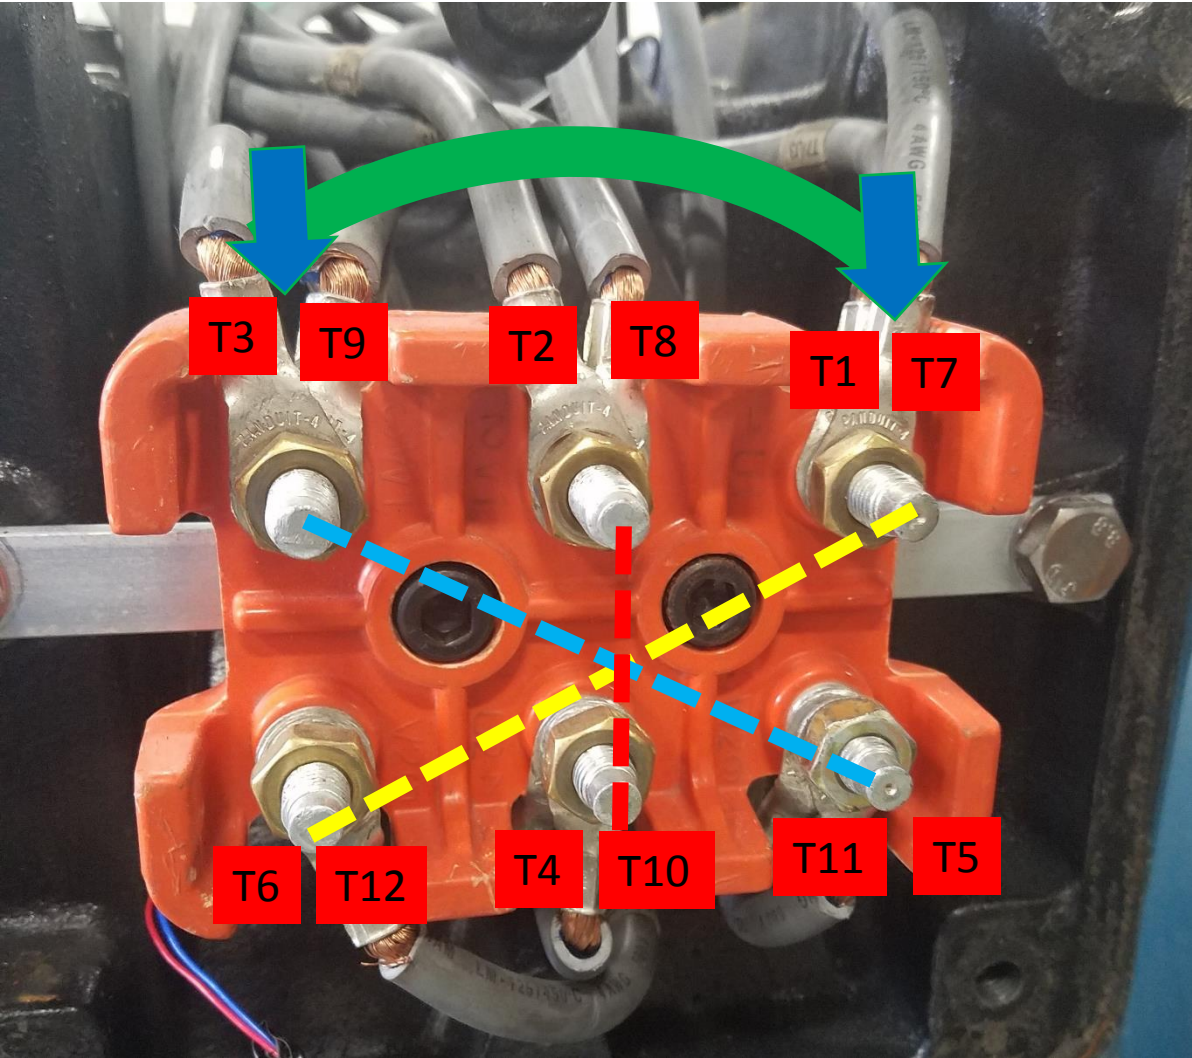
- (T3 & T9) and (T1 and T7) lugs were in wrong position [Designated by green/blue arrows]
- Dotted lines designate proper RUN connection per nameplate (page 2 of this report)
