Cause of Failure 600 HP Toshiba Motor

Dreisilker Electric Motors, Inc.

Motor Nameplate Information

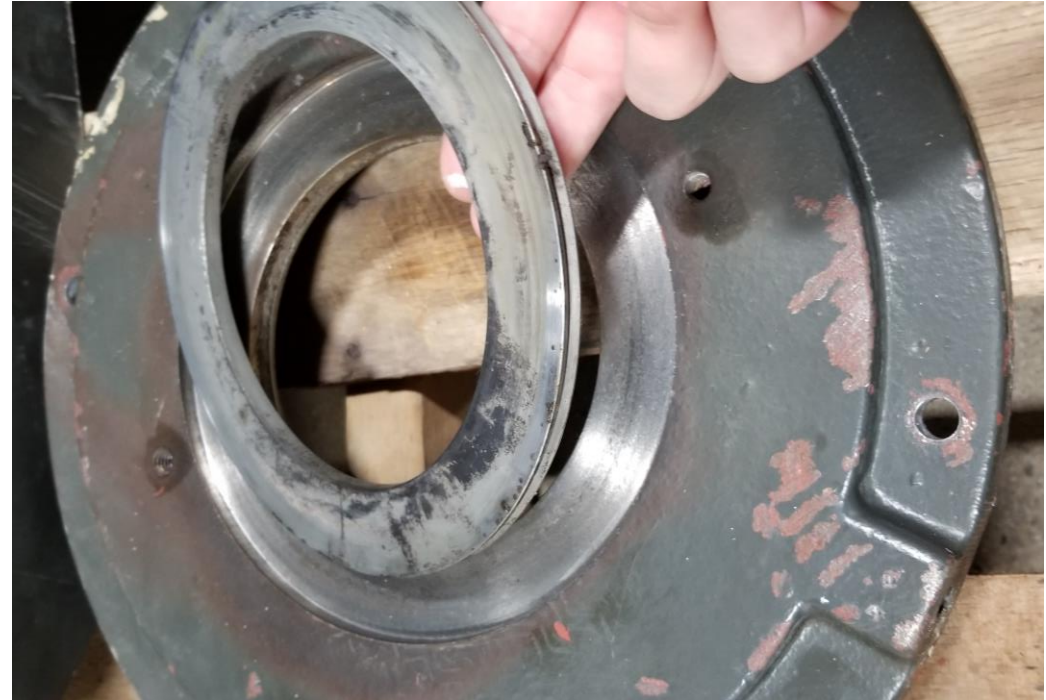
DE labyrinth and exterior bearing cap with felt seal

- Felt seal failed to keep contaminants out of bearing housing
- Water or liquid got under the DE bearing and rusted
- Contaminants scratched the rollers and raceway surfaces (more prominent on output shaft side because rust expands in size so the raceway was slightly pressed upwards)
- False brinelling occurred from external vibration source when motor was not operating in storage, transportation, or on machine during shutdown

- Prevent contamination from entering motor
- Dreisilker as an option has quoted modifying the outside bearing caps to hold a lip seal, replacing the felt seals
- Prevent exterior vibration sources when the motor is not in operation

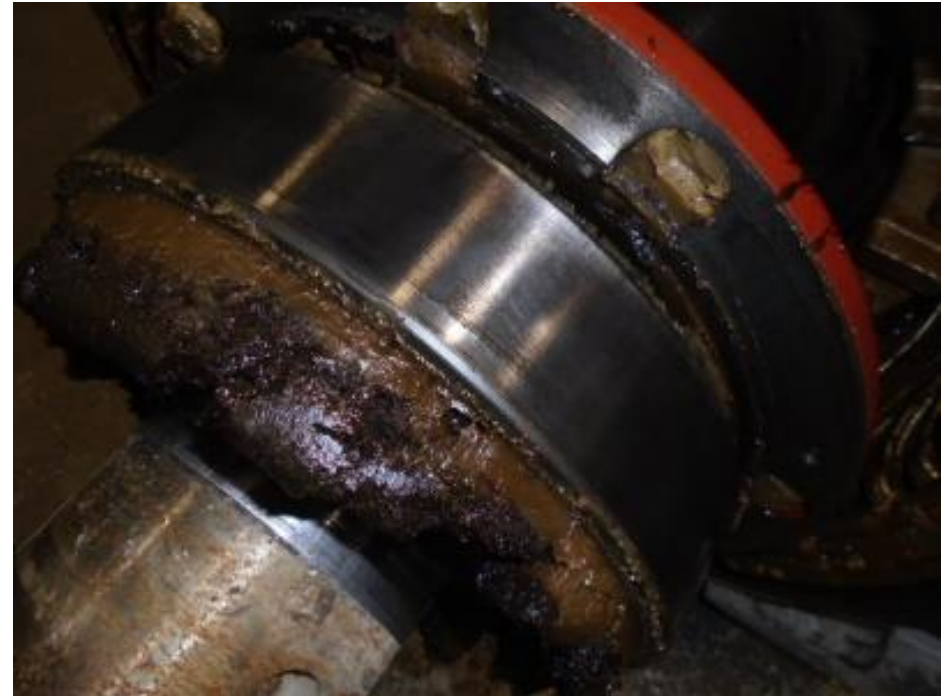
Drive End Bearing and Grease

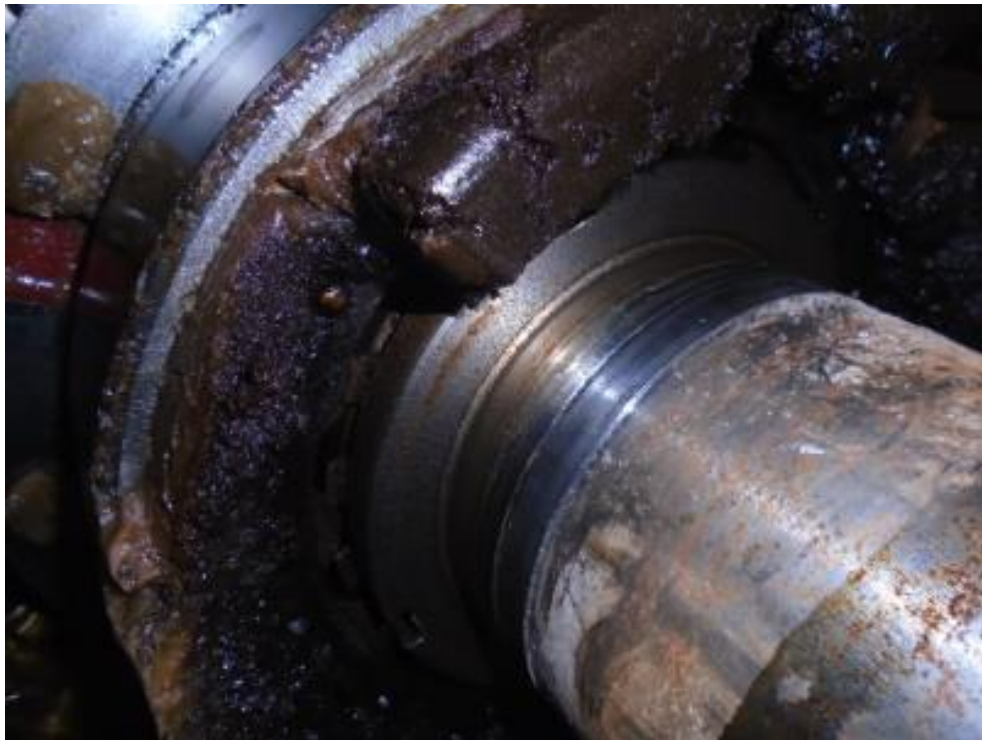
Drive End Bearing Grease

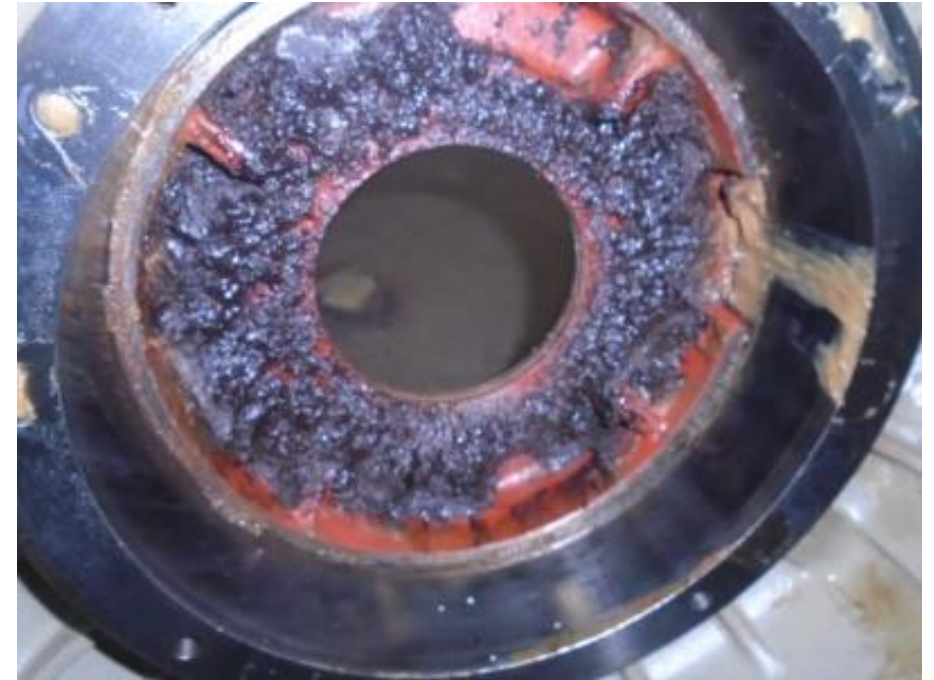
Drive End Bearing Housing Grease

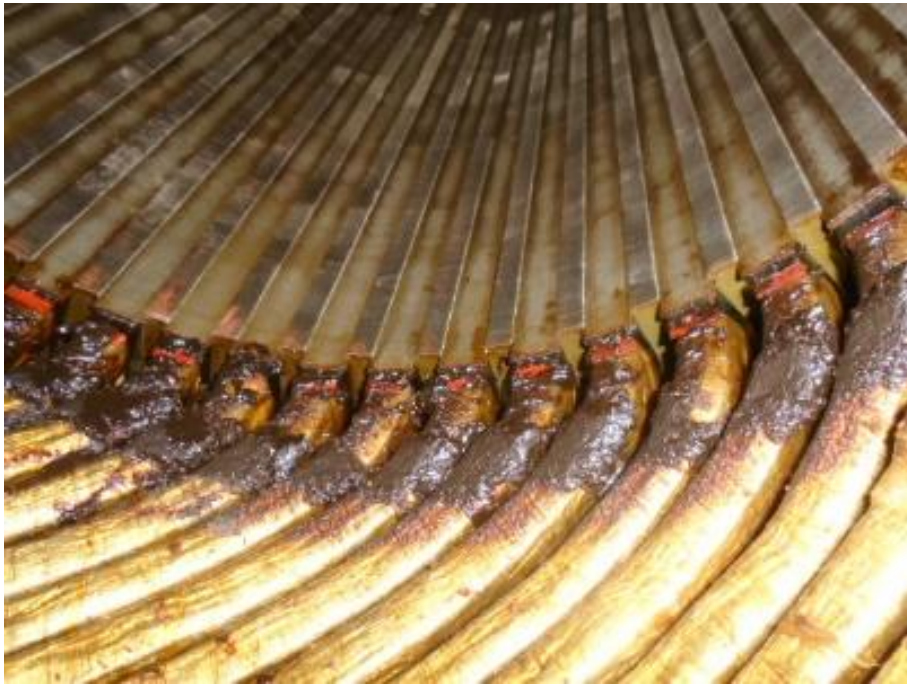
Grease on DE Winding Head

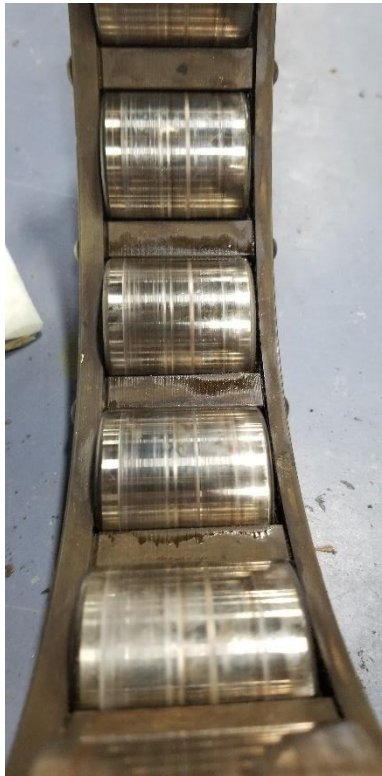
Scratch Marks on DE Bearing Rollers

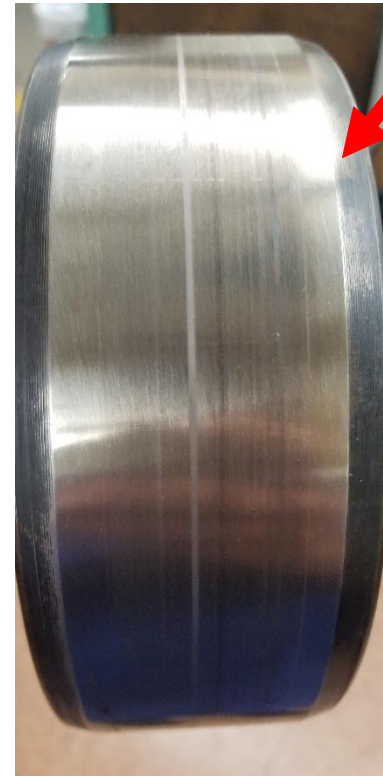
**Scratch Marks on DE Inner Raceway
(more prominent on output shaft side)**

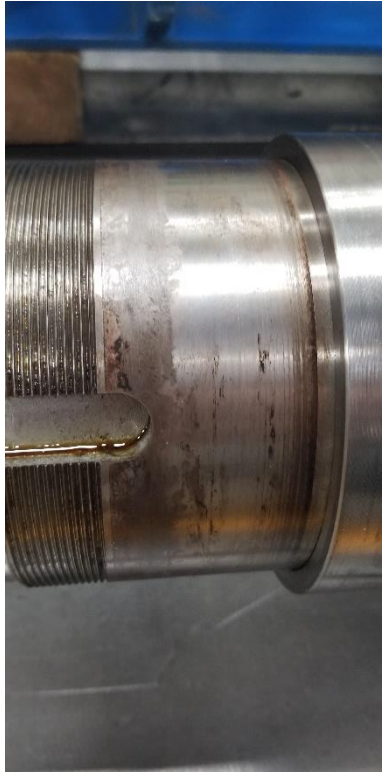
Rust or fretting on DE journal output shaft side (dimensionally all the same)

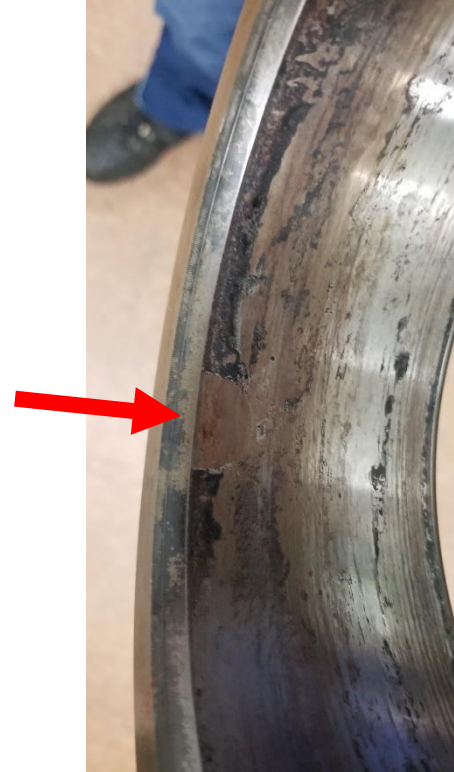
Rust or fretting on DE bearing inner race with visible mark of locknut keyway (red arrow)

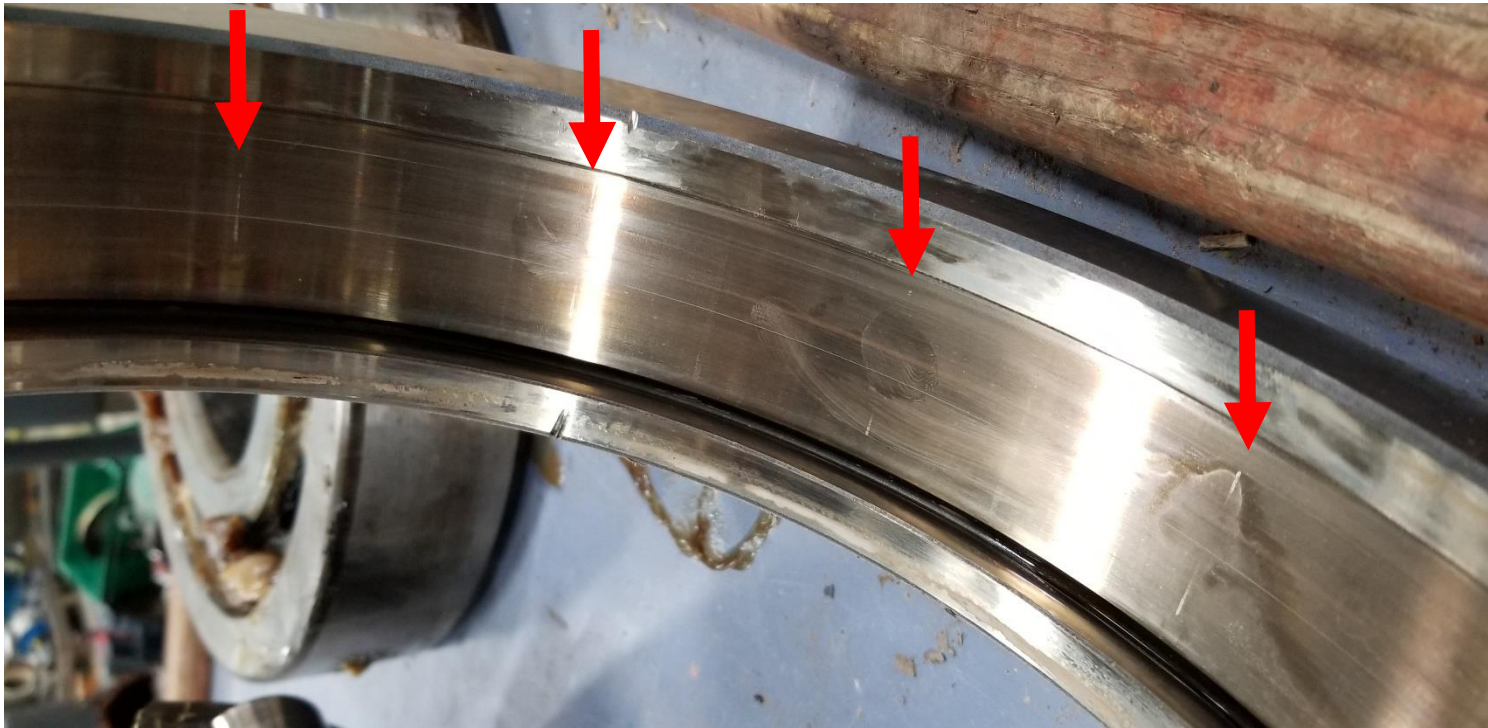
False Brinelling on DE bearing outer raceway

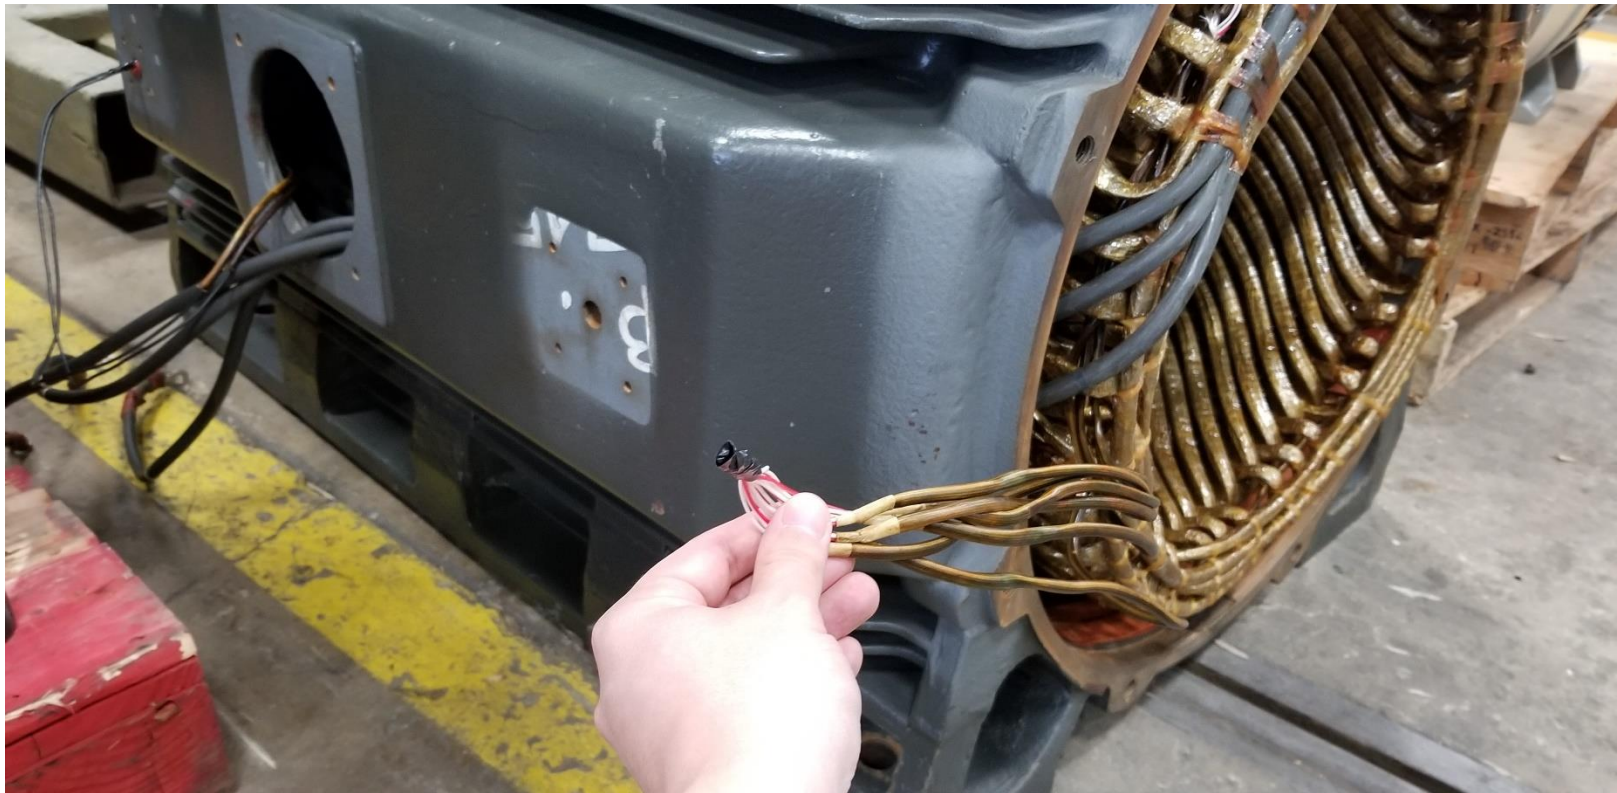
Winding RTD leads taped off and do not reach the terminal opening
