Cause of Failure – 250 HP WEG Motor

Dreisilker Electric Motors, Inc.

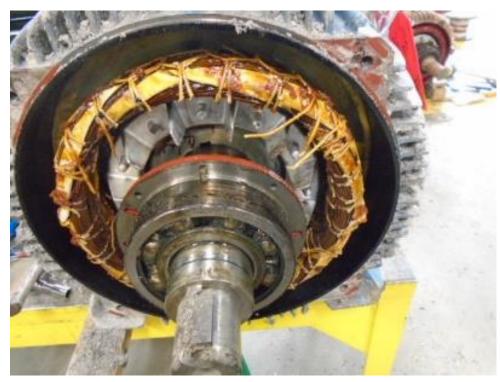
No contamination on inside, but winding ties broken

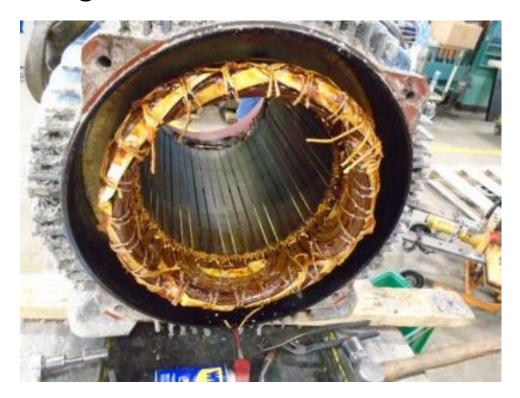
Winding ties broken

- One motor coil shorted to ground where it came out of the slot at an angle
- The winding overheated causing ties to break and white bubbling of insulation material to come out of slot
- It is unknown if coil shorted to ground first or if winding overheated first

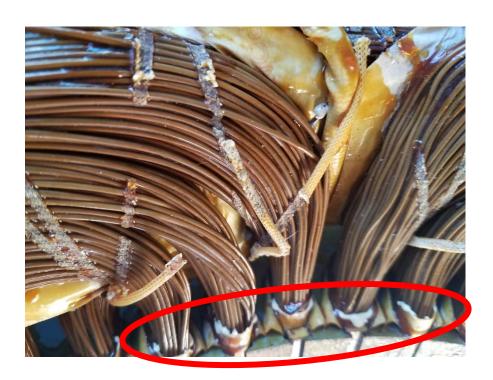
Winding ties broken and white bubbling of insulation material out of slots

- Manufactured and rewound motors coils should come straight out of the laminations slots before bending. Bending a coil on the edge of the slot will cause abrasion of insulating materials.
- Check the motor controls to make sure it did not cause an overloaded condition causing winding to overheat (however, no other evidence in other parts of this motor indicated an overload)

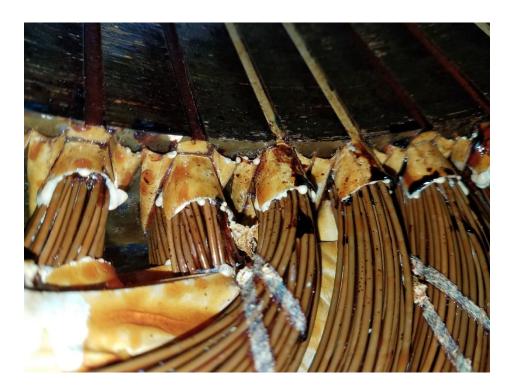
White bubbling of insulation materials and ties broken away

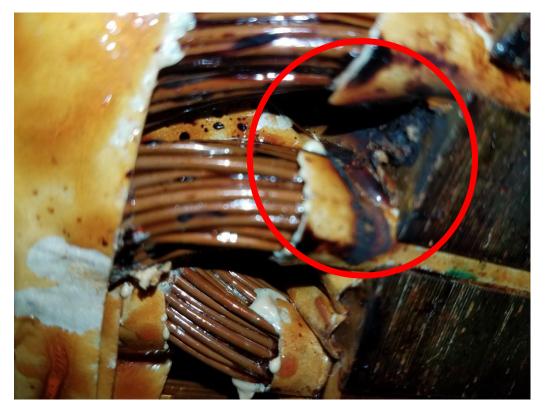
Coil that shorted to ground at edge of laminations

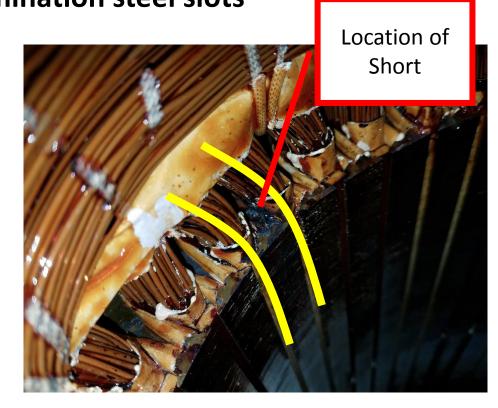
Coils bend at an angle coming out of lamination steel slots
