**Cause of Failure Report for 40 HP Unico DC Motor  
Job Number: 369035**

**Dreisilker Electric Motors, Inc.**

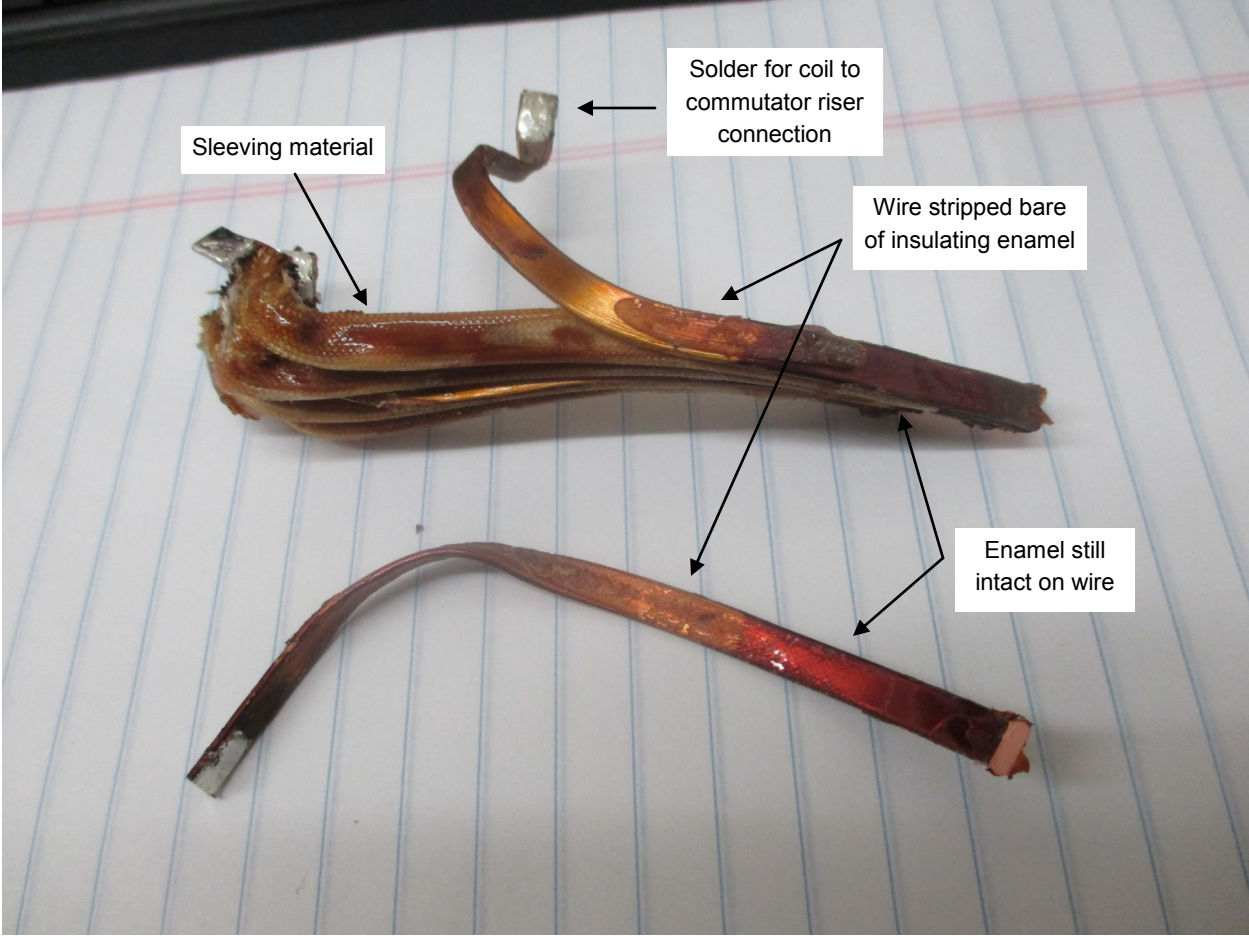
1. The insulating enamel on the copper wire was stripped too far back from the riser connection end (Figure One and Two). Wire insulating enamel is only needed to be stripped enough so that the armature coils can connect in the commutator riser slots via solder. There was varnish and sleeving present however there were some bare spots with poor varnish coverage on the wires and sleeving (Figure Two). The sleeving alone does not provide the same insulating strength as the combination of sleeving, varnish, and wire enamel.

Figure One: Showing Grouping of Stripped Wires from Armature

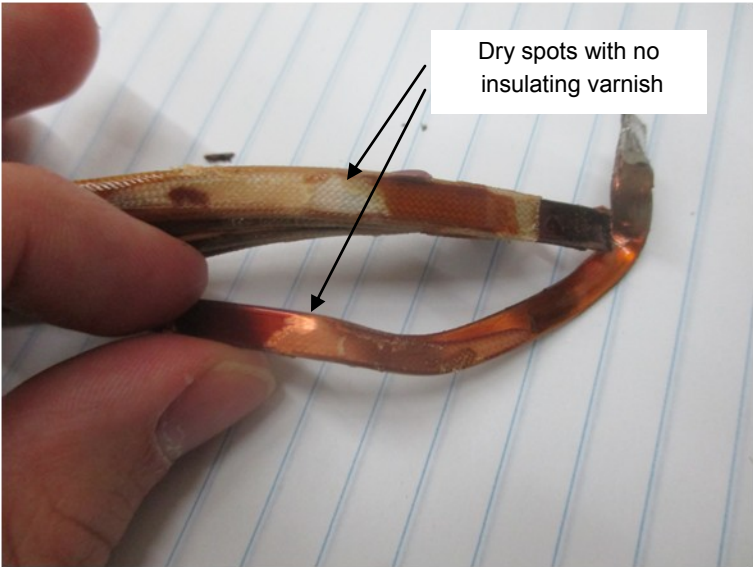
Figure Two: Separated Wire from Grouping Showing Poor Varnish and Insulation Coverage

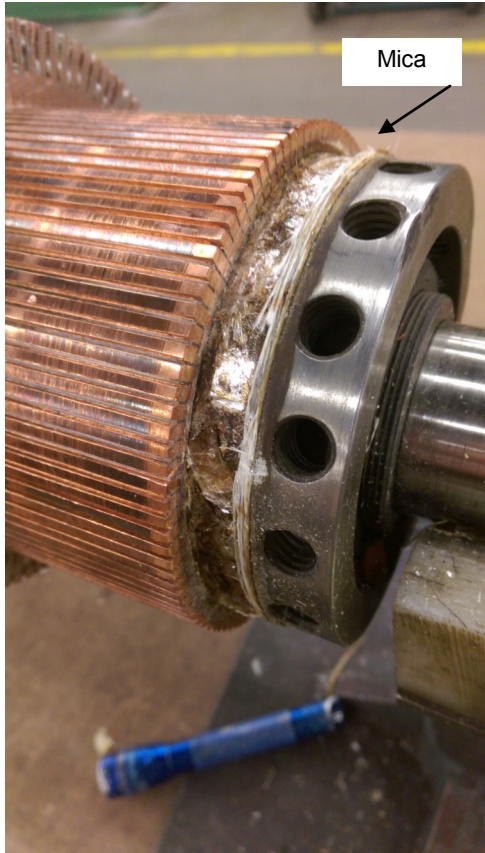
2. After removing insulating tape from the commutator v-ring behind the riser from the previous rewind, there were two findings:
  - A. The insulating mica had been removed from behind the riser exposing the steel of the commutators v-ring (Figures Three and Four).

Figure Three: Tape/Banding from previous rewind removed to see if mica insulation was in place

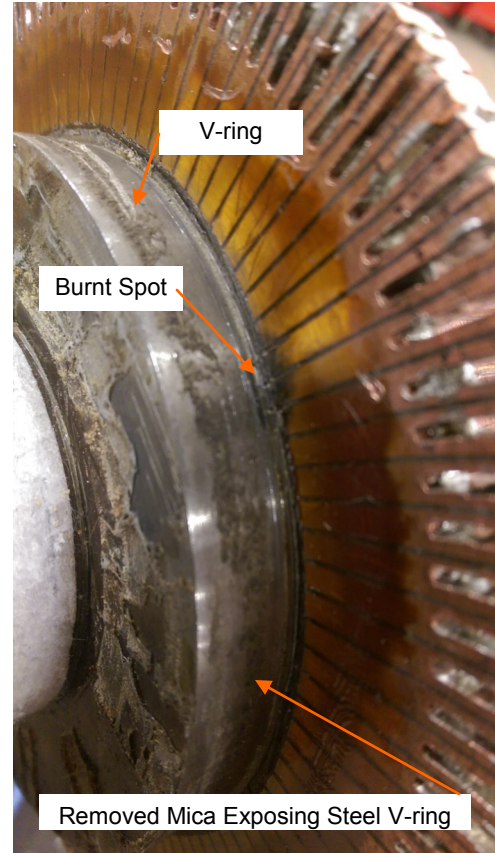
- B. There was visible evidence of a burnt spot at the bottom of three commutator bars on the riser side (Figure Four and Five ).

The absence of insulation between the commutator riser and the v-ring caused a short between coils. In addition, the use of insulating tape and lack of mica on the steel of the v-ring could have trapped dirt causing it to arc between commutator turns or short to ground via the uninsulated steel v-ring. A proper commutator should have the insulation materials to prevent short to ground or short between commutator bars. Note in Figures Six to Eleven, the commutator has been rebuilt and insulation covers the steel.

Figure Four: After removing banding, the mica insulation was found to have been removed and a burnt spot is visible where the commutator bars meet the steel spool at the bottom of the riser

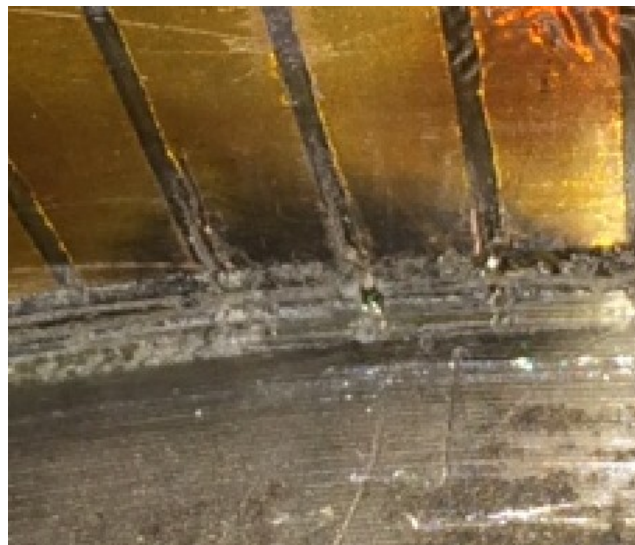
Figure Five: Close up of the burnt spot on the commutator riser
