Impact of Burnout Oven Stripping on Rewound Motor Reliability and Rewinding Considerations

Thursday, August 24th, 2017

Leo Dreisilker – President of Dreisilker Electric Motors, Inc.

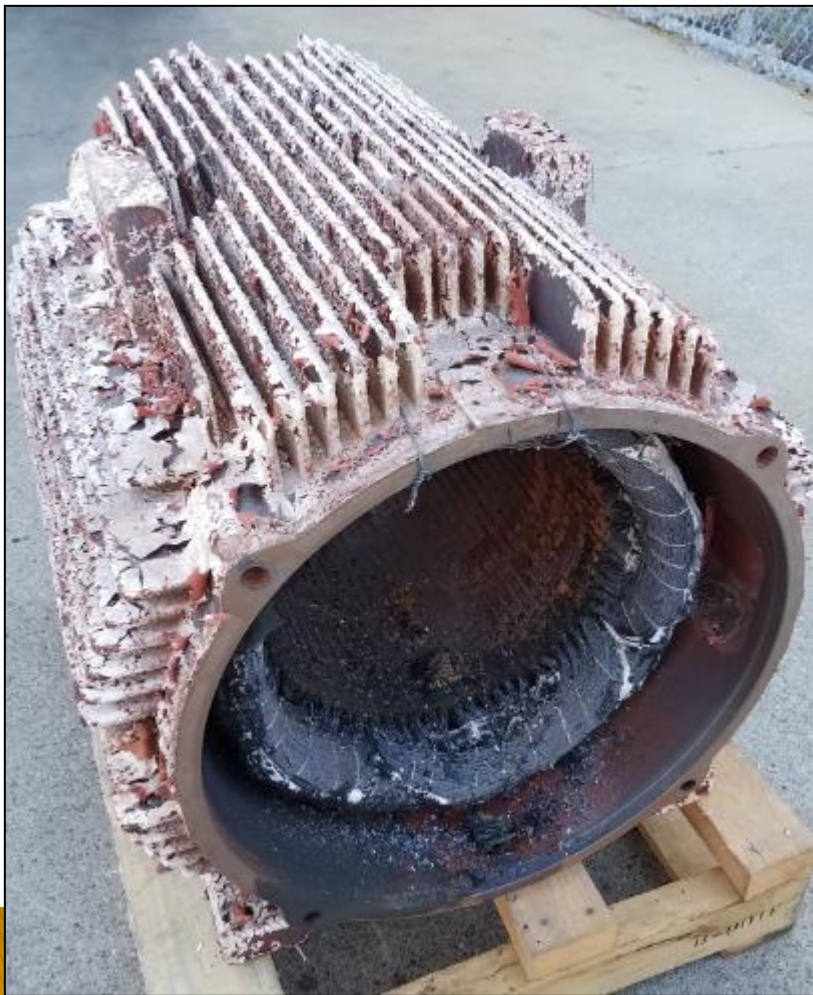
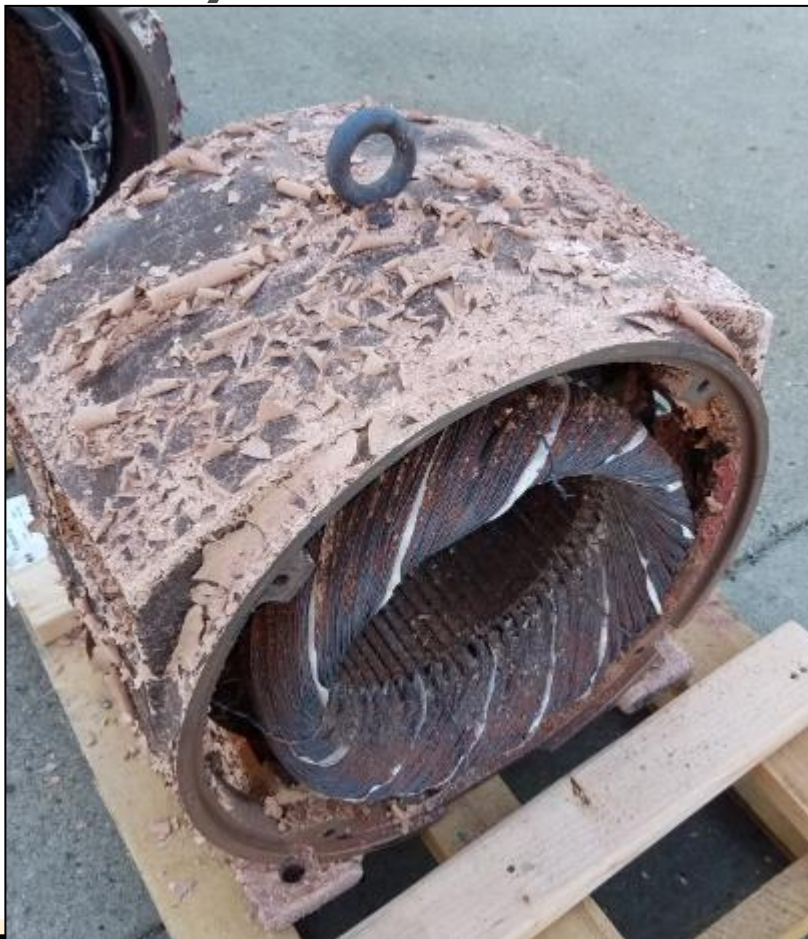
Case Study of Burnout Method After Oven Cycle

- Oven started at 8:30am and reached 750 °F at 10:30 am.
- Between 1.5 to 2 hours temperature reached over 800 °F and fire suppression system activated to quench the fire from the burning winding insulation
- At 7am the next day, the internal oven temperature was at 114 °F before opening doors to remove stators

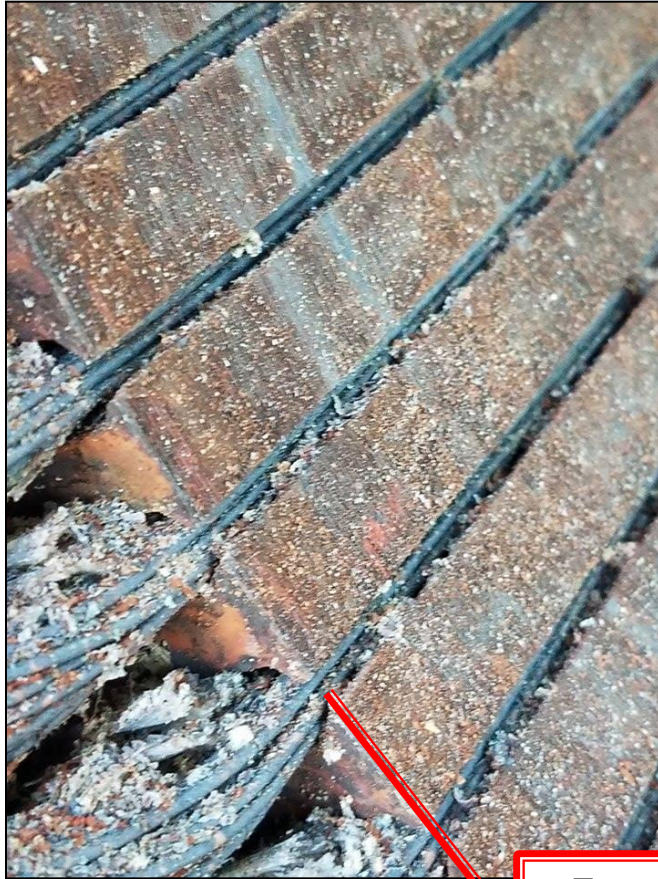
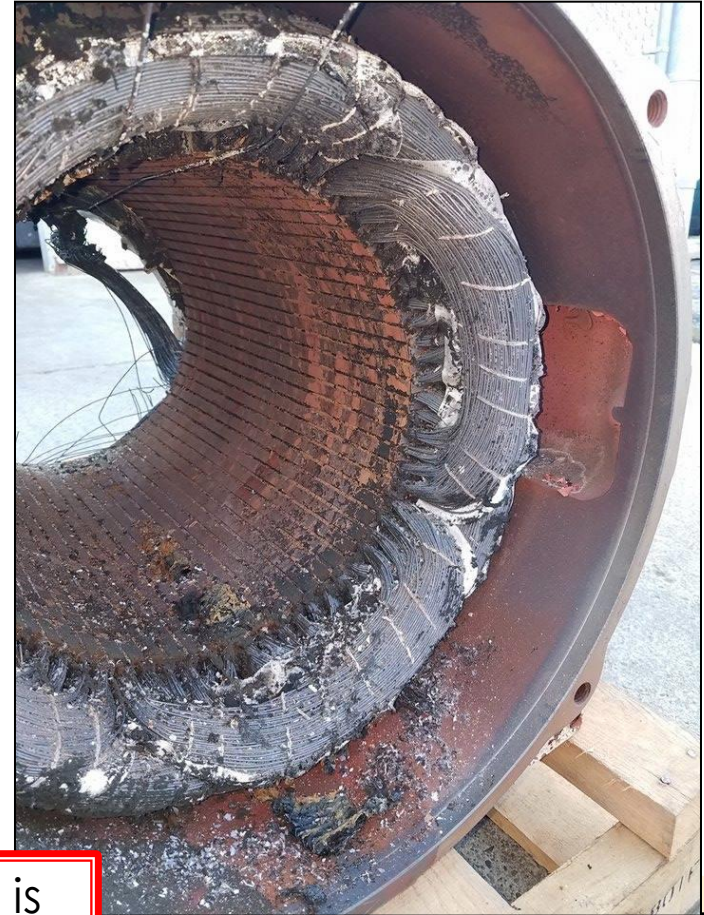
Top wedge is completely incinerated

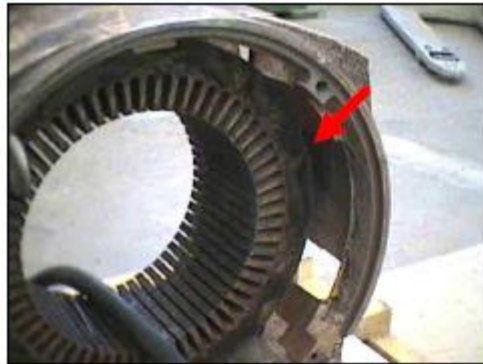
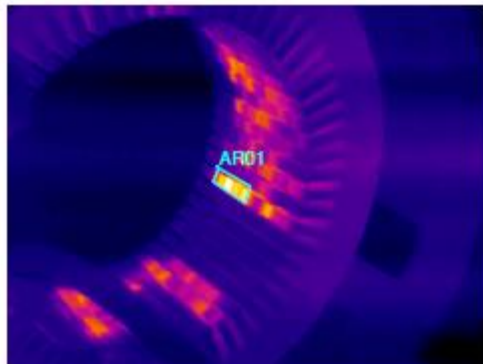
Before and After Findings: Infrared of 100 HP

100 HP	Core Loss (W's/lb.)	Hotspots?
Before	4.678	No
After	10.101	Many

Fault	
Object parameter	Value
Emissivity	0.96
Object distance	1.0 ft
Label	Value
AR01 : max	67.3°C
AR01 : max-min	41.1%

153.14 °F
(67.3 °C)

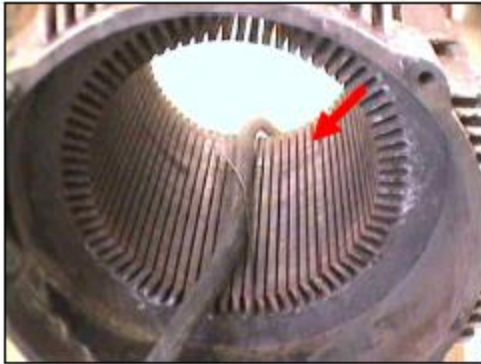
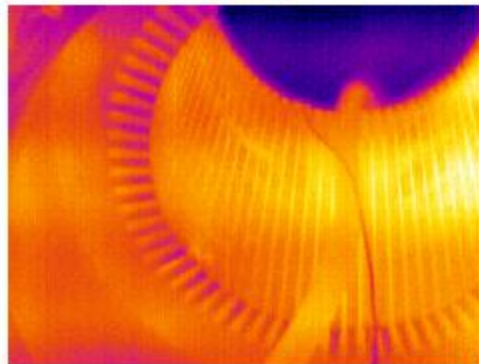
Before and After Findings: Infrared 200 HP

200 HP	Core Loss (W's/lb.)	Hotspots?
Before	2.473	No
After	2.028	No

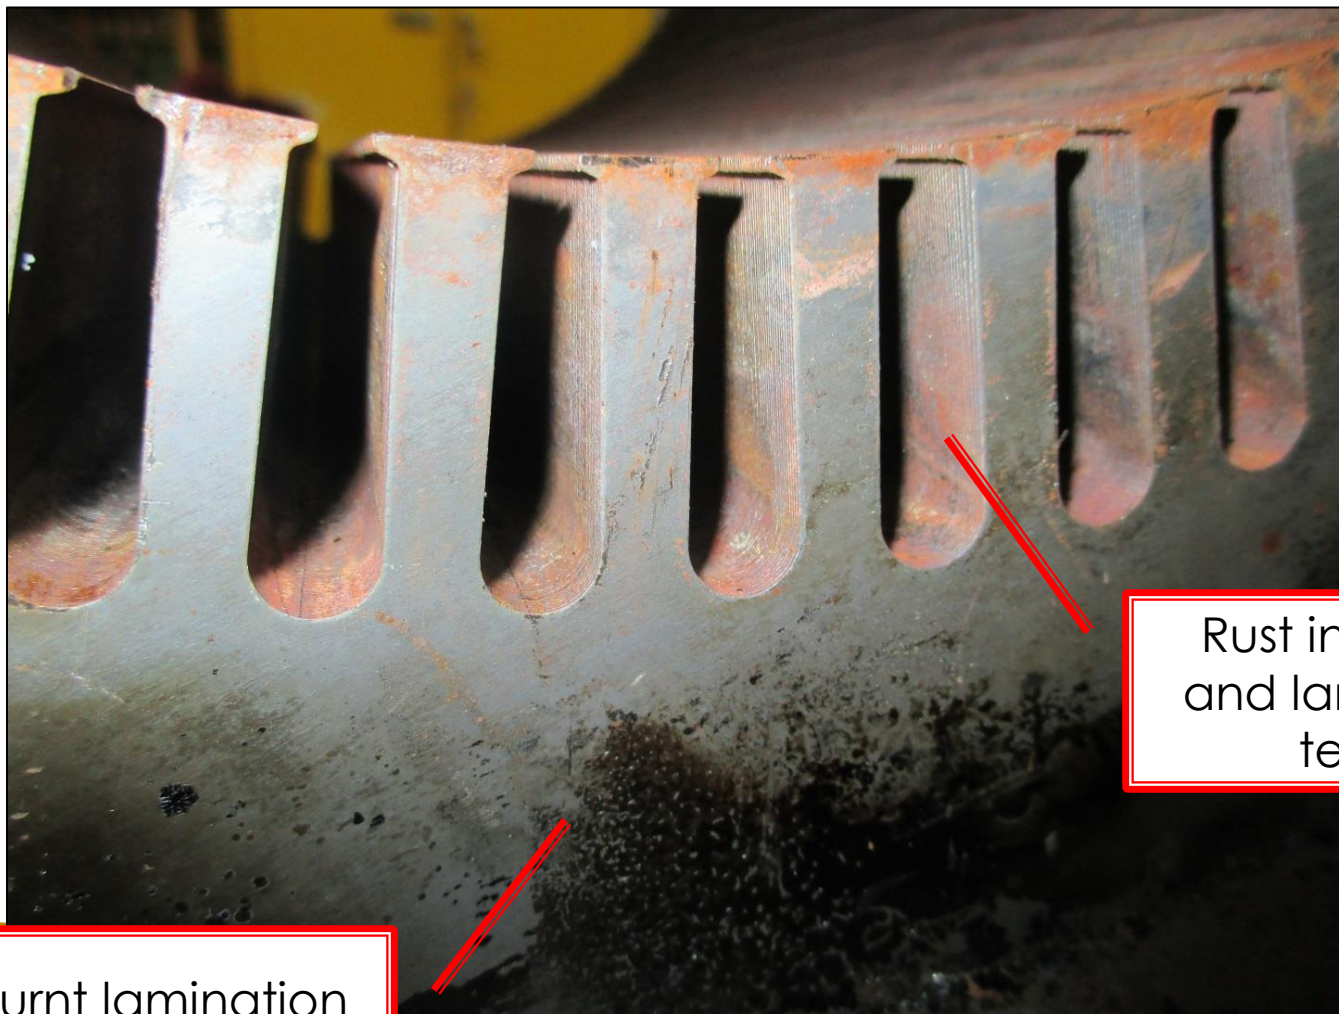
Rusted Burnout Laminations from 200 HP Motor

- Core Loss: 2.473 to 2.028 W's/lb.
- **Why?**
 - Rust developed from fire suppression system sauna effect
 - Rust(Iron-Oxide) is an insulator
 - Rust develops between the motor laminations
 - Five Laminations were removed and presence of rust was found between each

Rust in all slots
and lamination
teeth

Burnt lamination
varnish

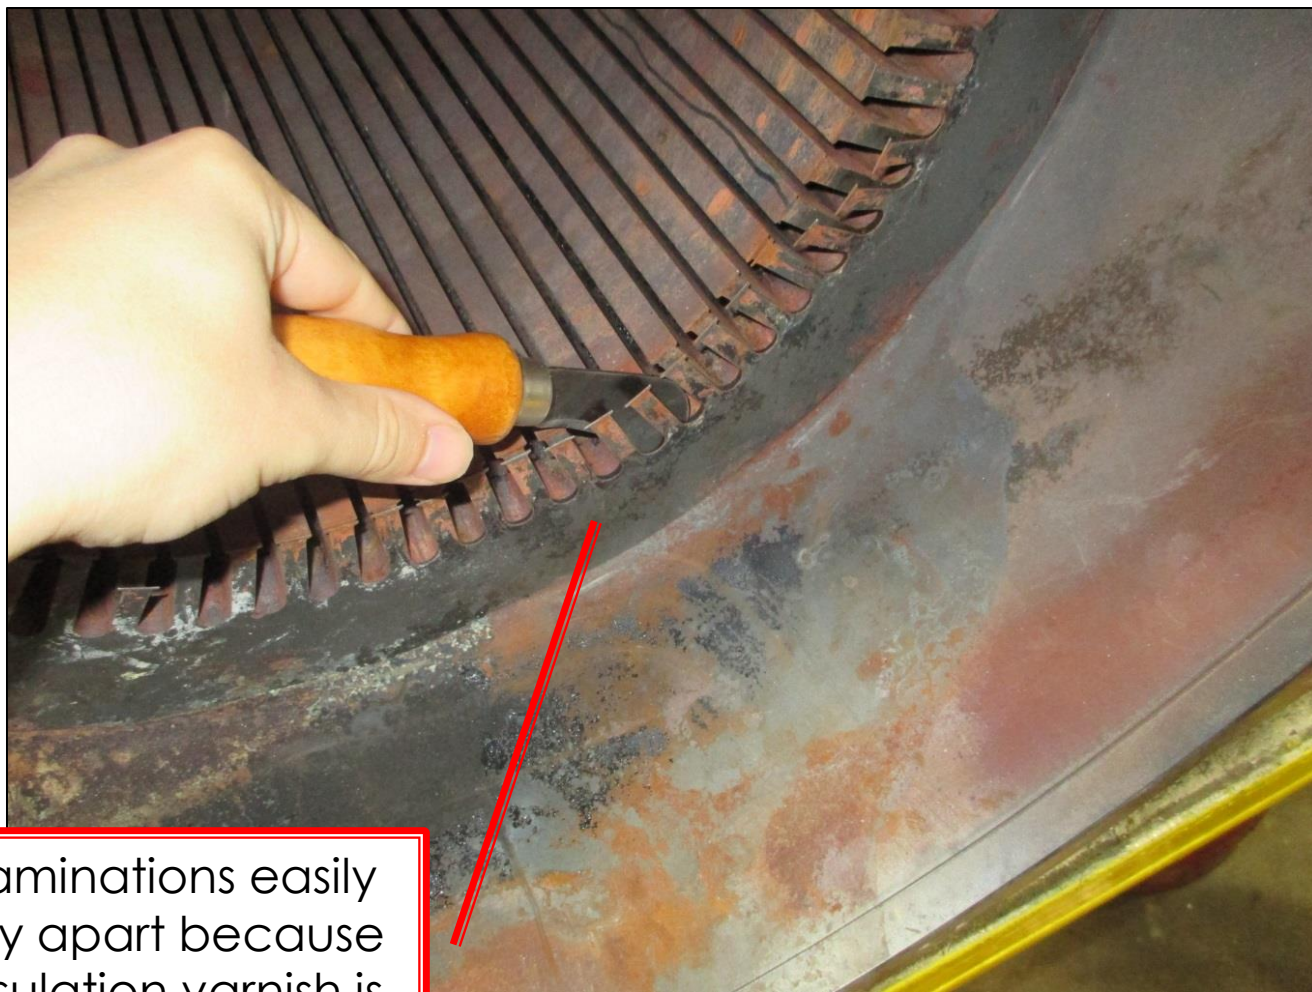
Rusted Burnout Laminations from 200 HP Motor

Laminations easily pry apart because insulation varnish is burnt away

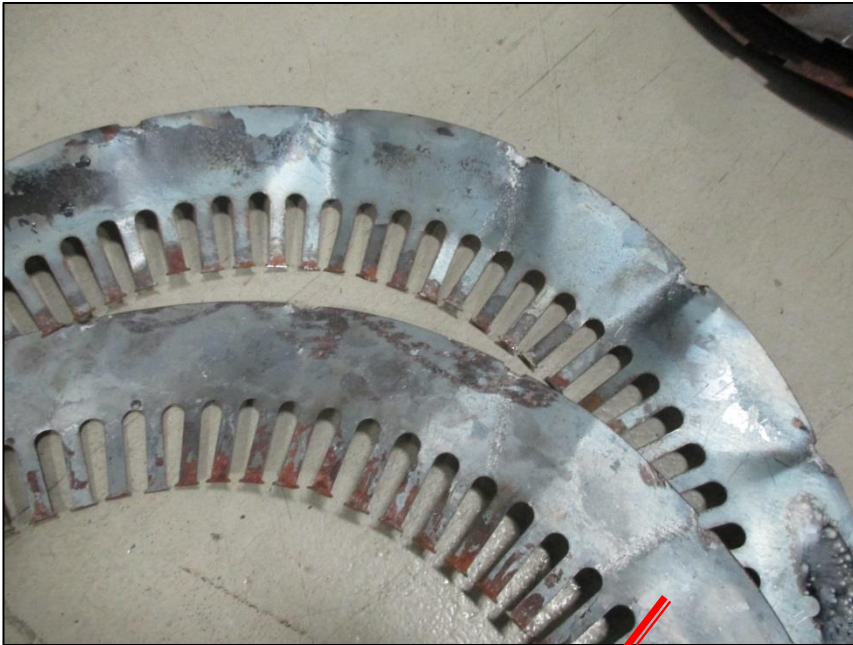
Burned out 200 HP
Laminations

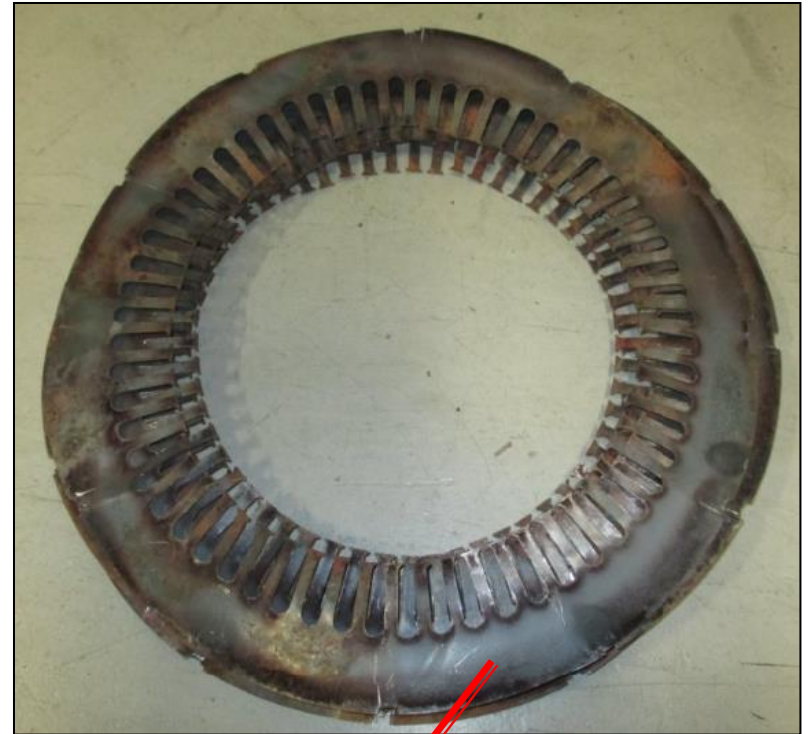
Burned out 100 HP
Laminations

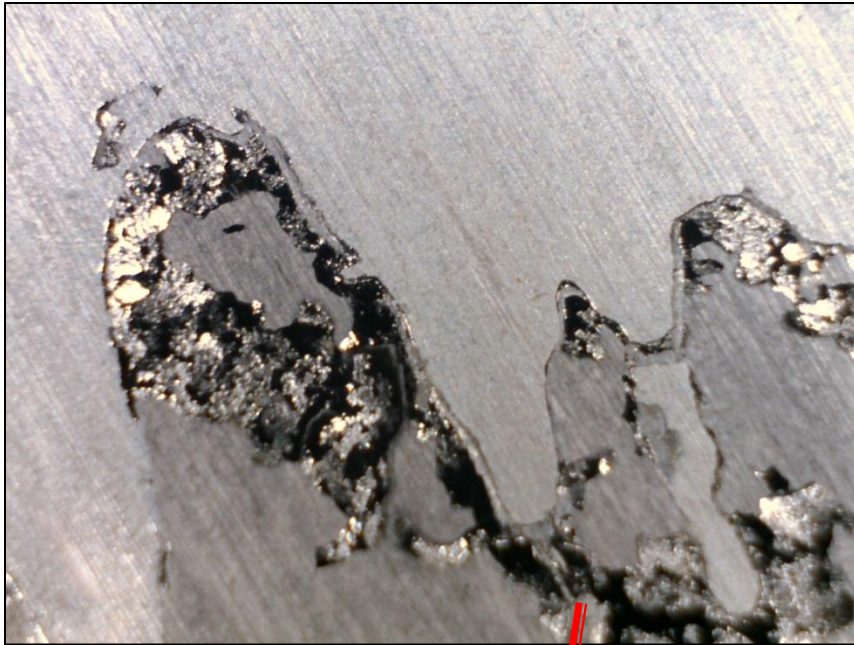
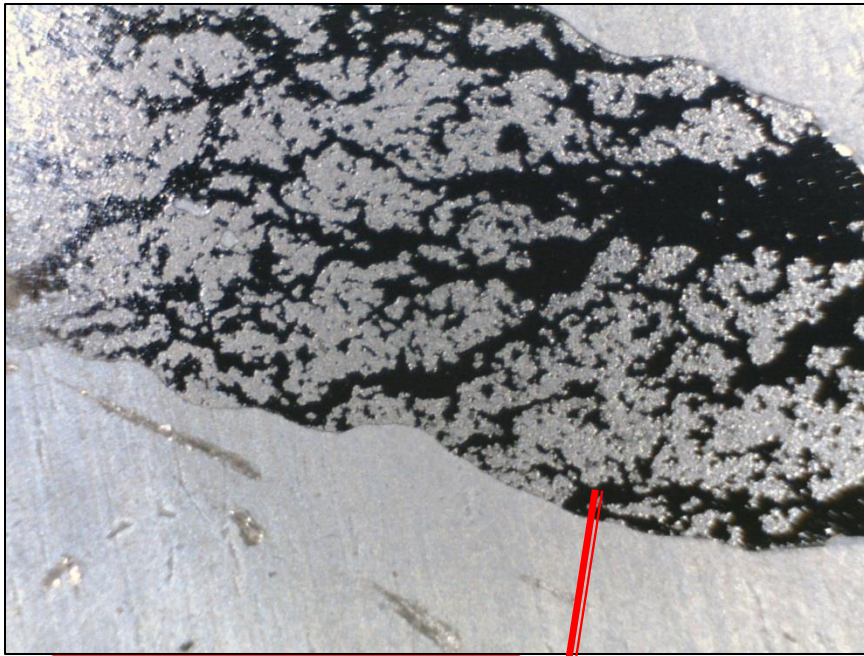
200 HP Internal Laminations After Burnout Microscopic View

Coating has melted exposing bare steel

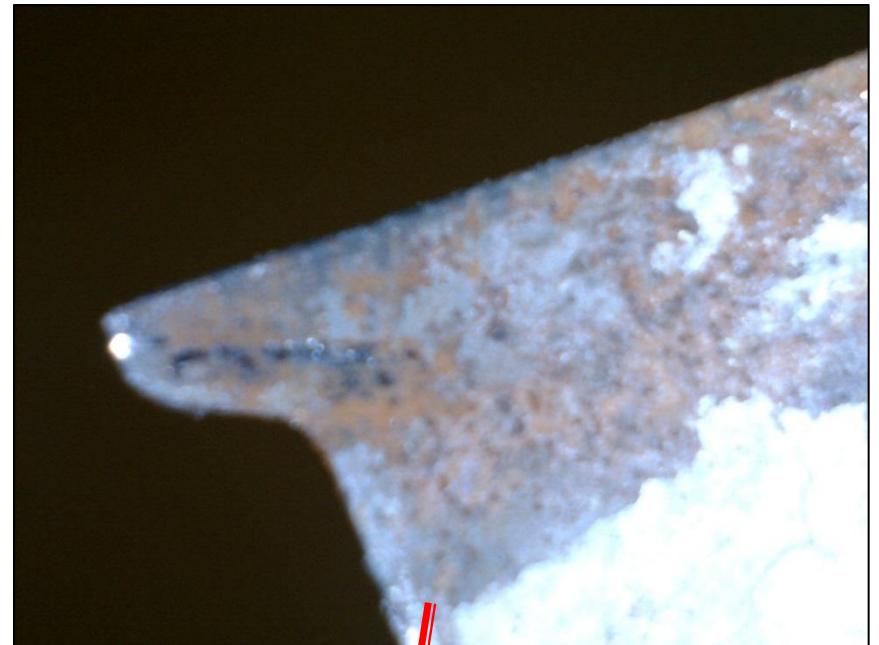
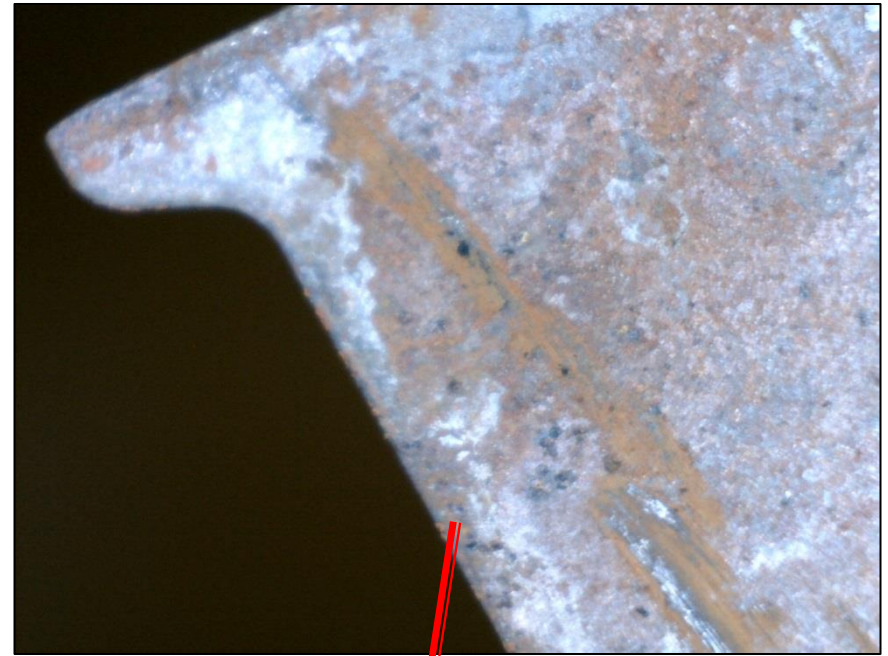
Slot teeth has rusted

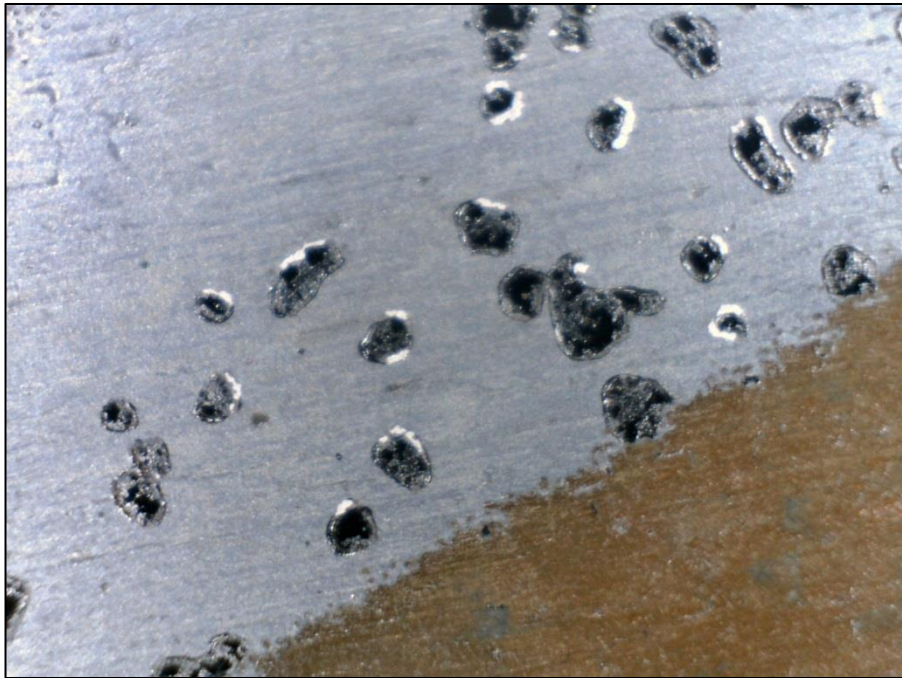
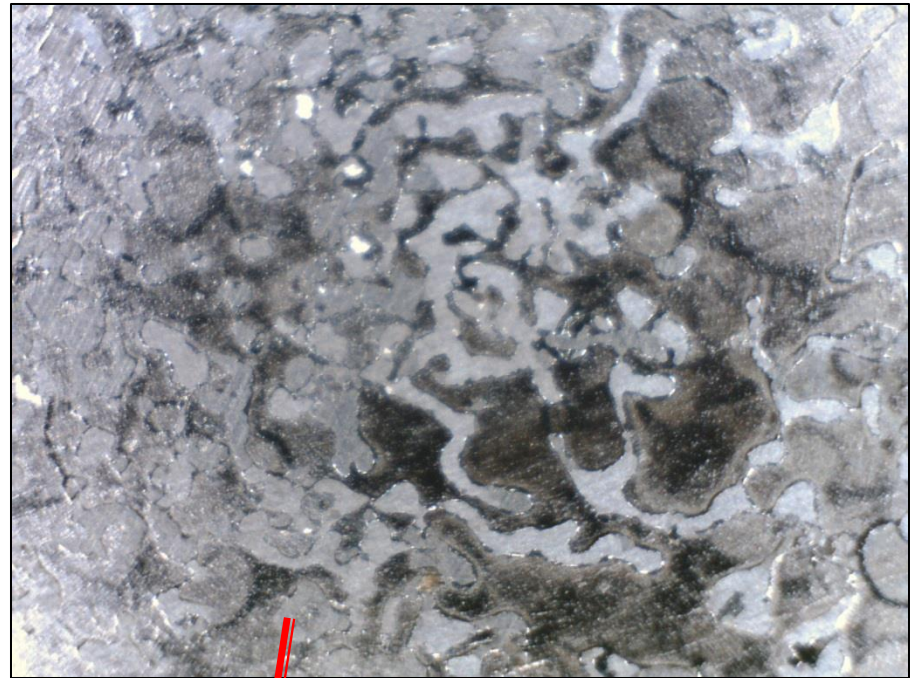
200 HP Internal Laminations After Burnout Microscopic View

Melted lamination
coatings

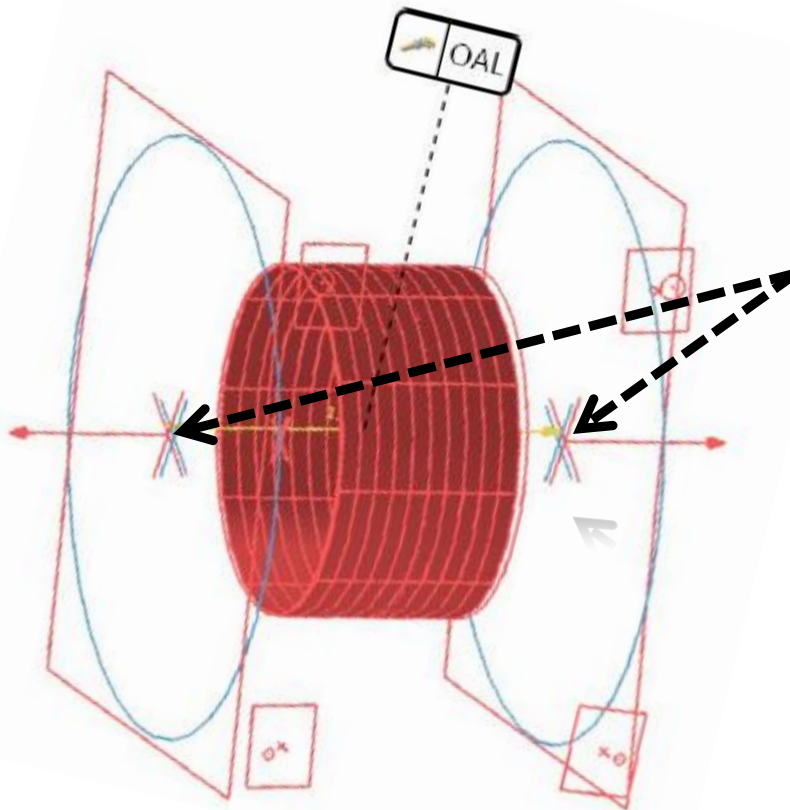
Opposite Drive side Offsets

Offset	Before	After	Change
X	-0.018	-0.004	0.014
Y	-0.019	0.0059	0.025

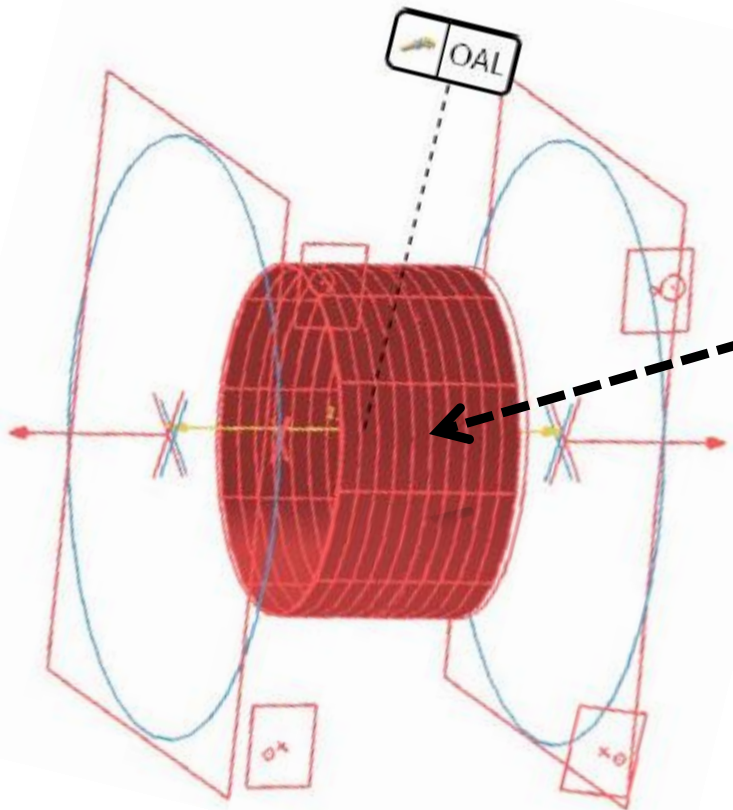
Lamination Bore

Dimension	Before	After	Change
Diameter	11.498	11.499	0.001
Cylindricity	0.005	0.010	0.005

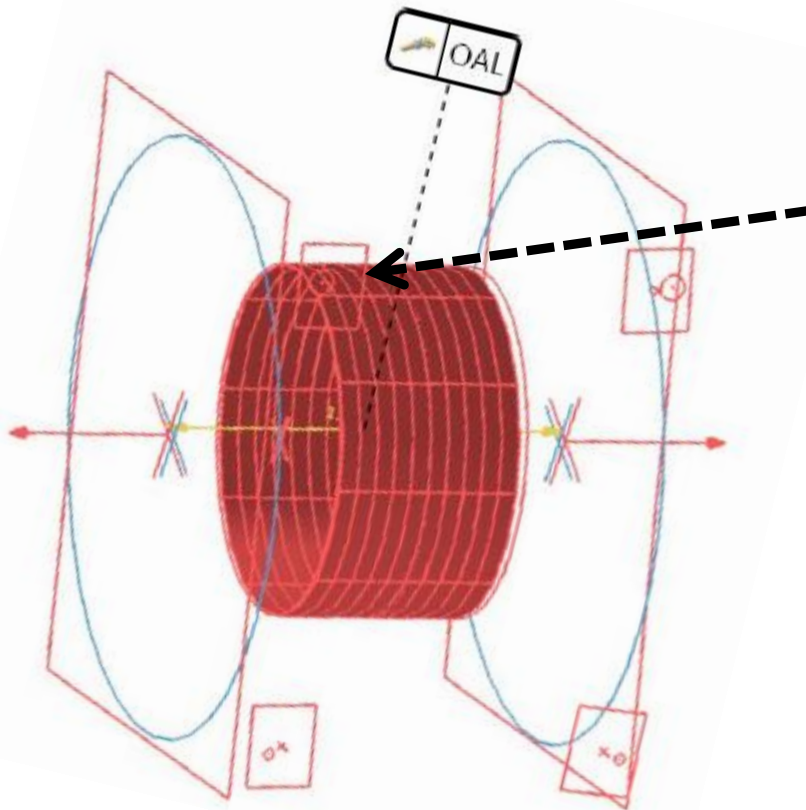
Foot Parallelism to Foot 1

Foot	Before	After	Change
2	0.000	0.003	0.003
3	0.000	0.009	0.009
4	0.000	0.005	0.005

*IEEE 1068-2015 specifies coplanar tolerance of 0.005 in

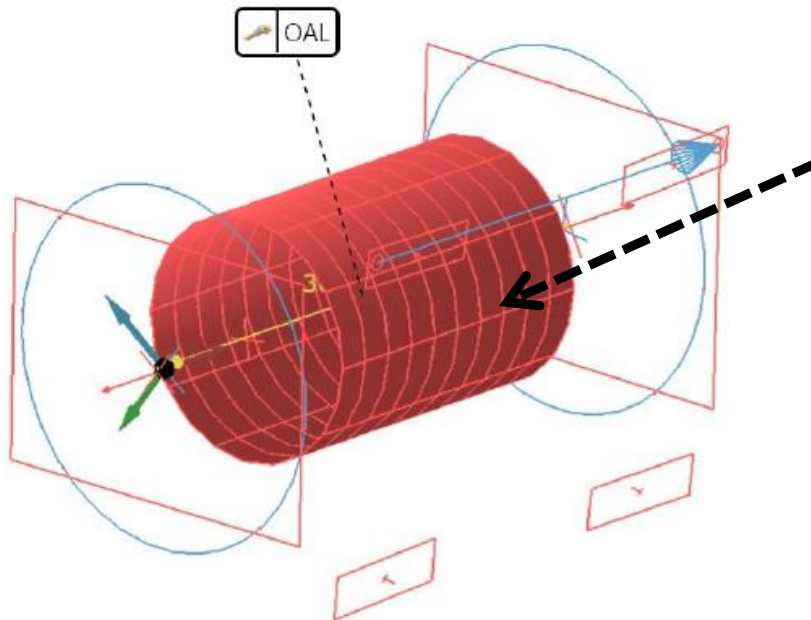
Lamination Bore

Dimension	Before	After	Change
Diameter	12.611	12.601	-0.010
Cylindricity	0.010	0.014	0.004

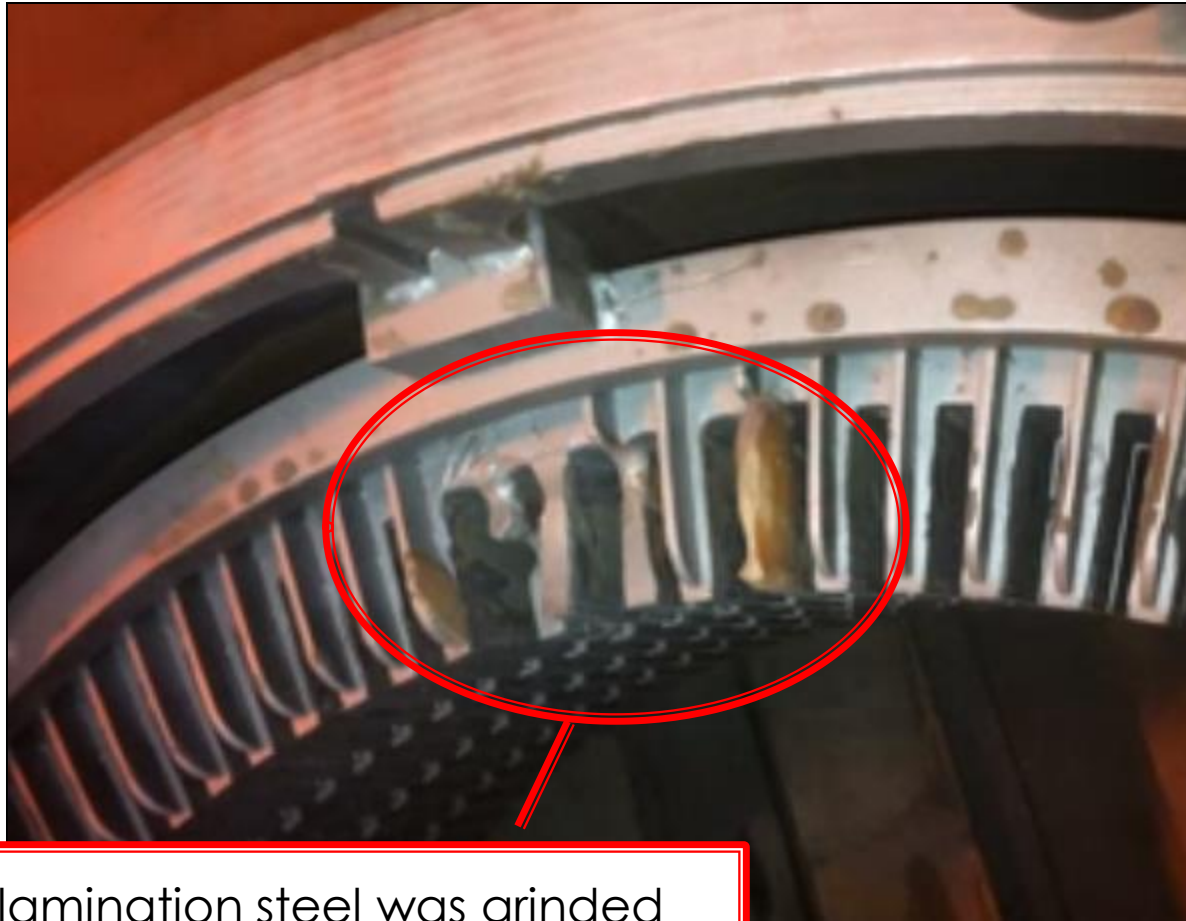
This motor's lamination steel was grinded away and repaired with epoxy. If this motor was stripped with a burnout oven, the epoxy would have been destroyed and not found.

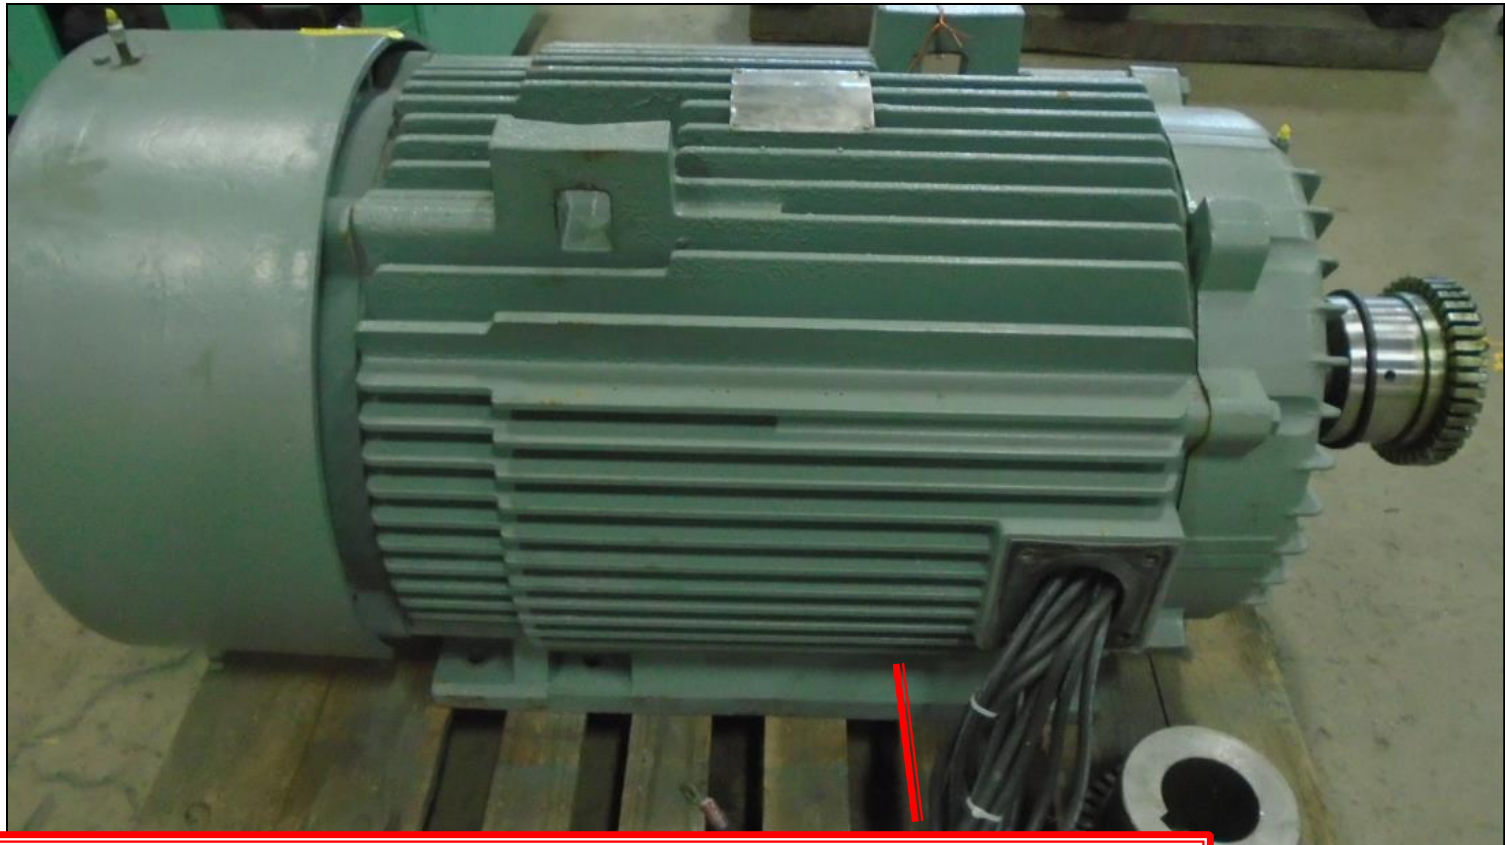
This a 400 HP motor that was repaired with burnout oven stripping and failing every 2 months.

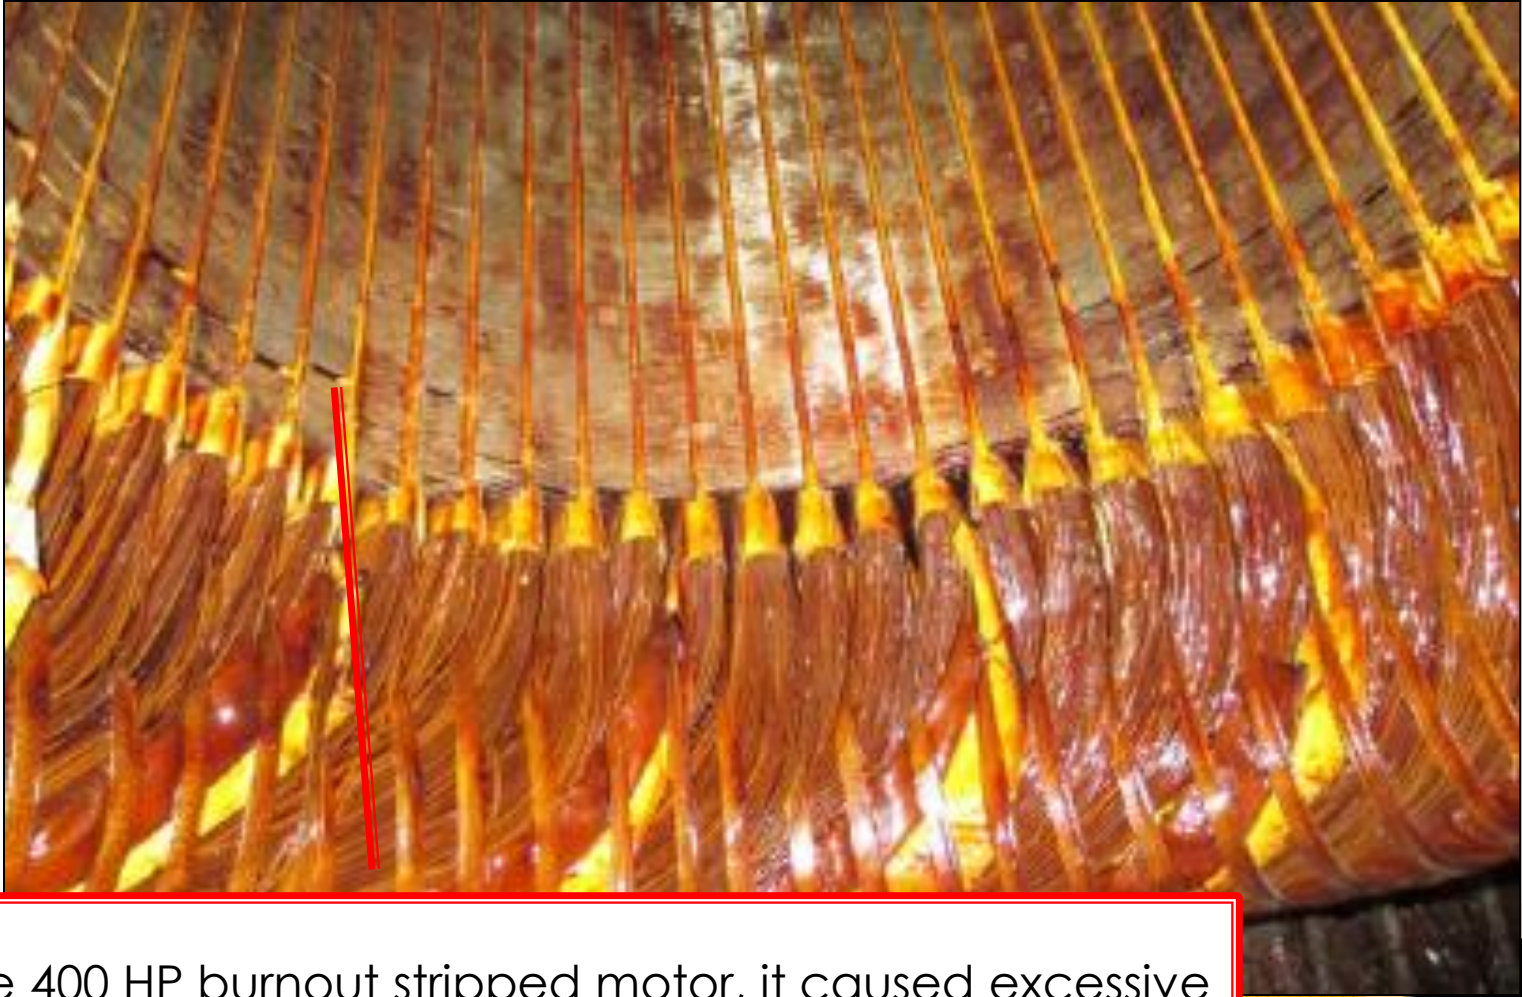
On the 400 HP burnout stripped motor, it caused excessive splaying causing air gaps between laminations..

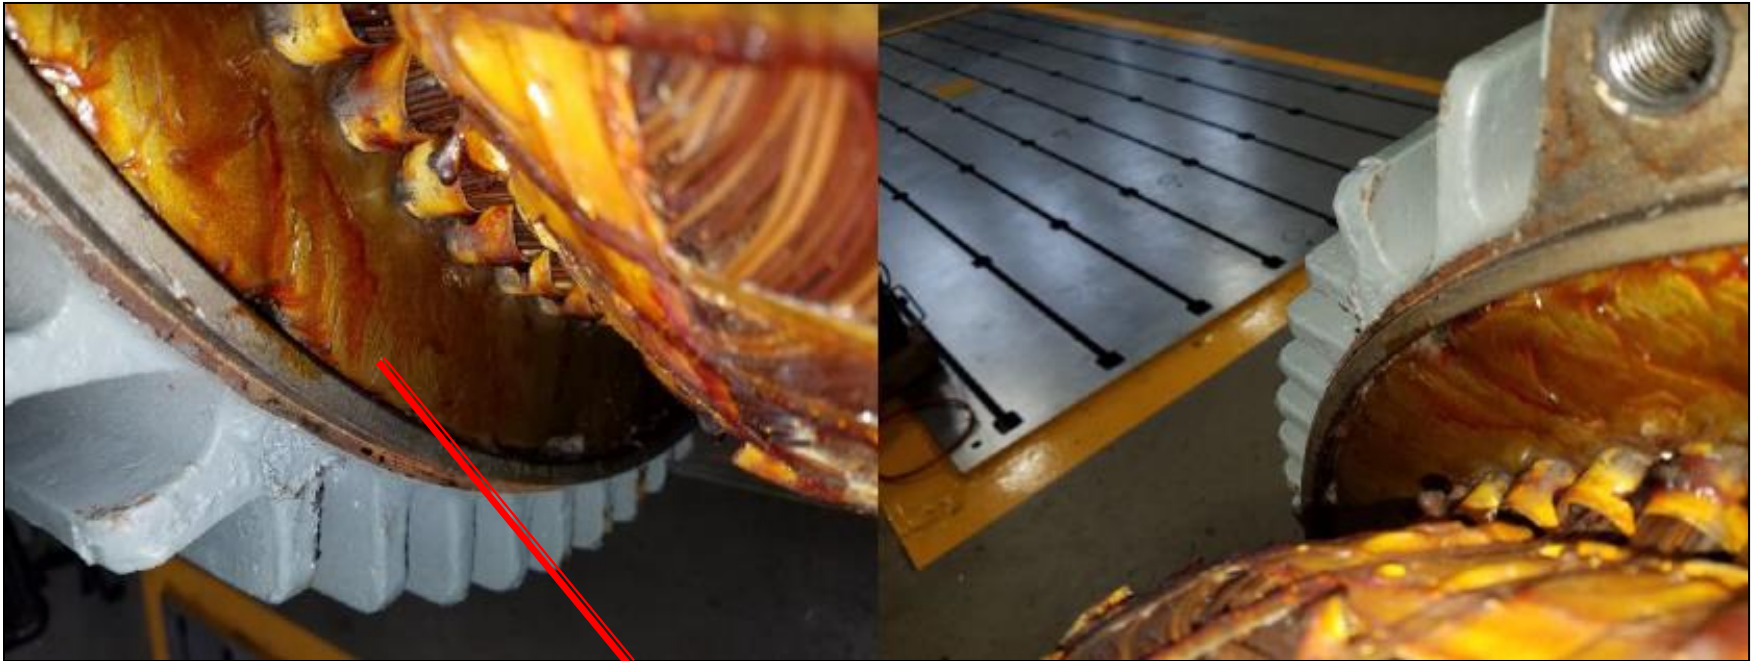
Entire lamination stacked was dropped and warped during stripping.

On the 400 HP burnout stripped motor, the entire lamination core dropped in the frame causing the winding and rotor to be off center as well as the laminations to be warped.

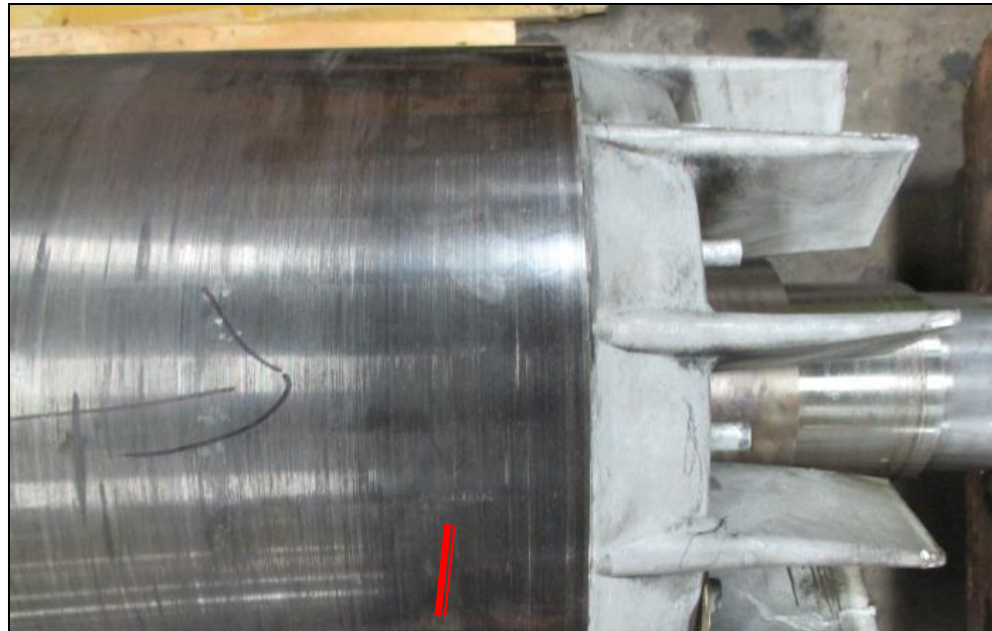
The stator was off center to the rotor by one inch. Bearings were failing in six months.

On the 400 HP burnout stripped motor because the core was not in the correct location, the rotor stuck out one inch and caused a magnetic pull on the rotor putting a high axial thrust load on the bearings which cause premature failure.
