Mechanical Impact of High Temperature Stripping Of Induction Motor Stators

Howard W Penrose, Ph.D., CMRP
Vice President, Engineering and Reliability Services
Dreisilker Electric Motors, Inc.

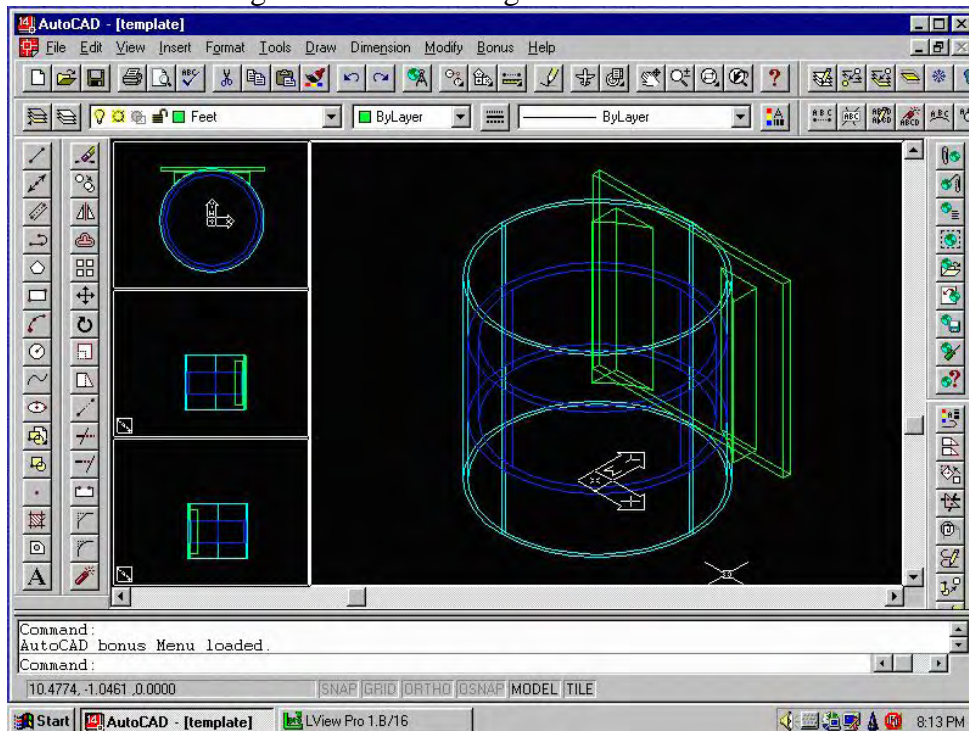
Figure 3: 3D Modeling with AutoCAD 14

Modeling the results created an understanding of what was truly happening to a motor in which even minor distortion was occurring. Those results were fairly dramatic and go a long way to help determine why some repairs do not seem to last as long as others.
